SF310 Near miss investigation report No.59

Contract/Location :	M1 J19 to J16 RCB Scheme	Contract no:	BM1730
Date of incident:	16/05/2015	Time of incident:	01:36

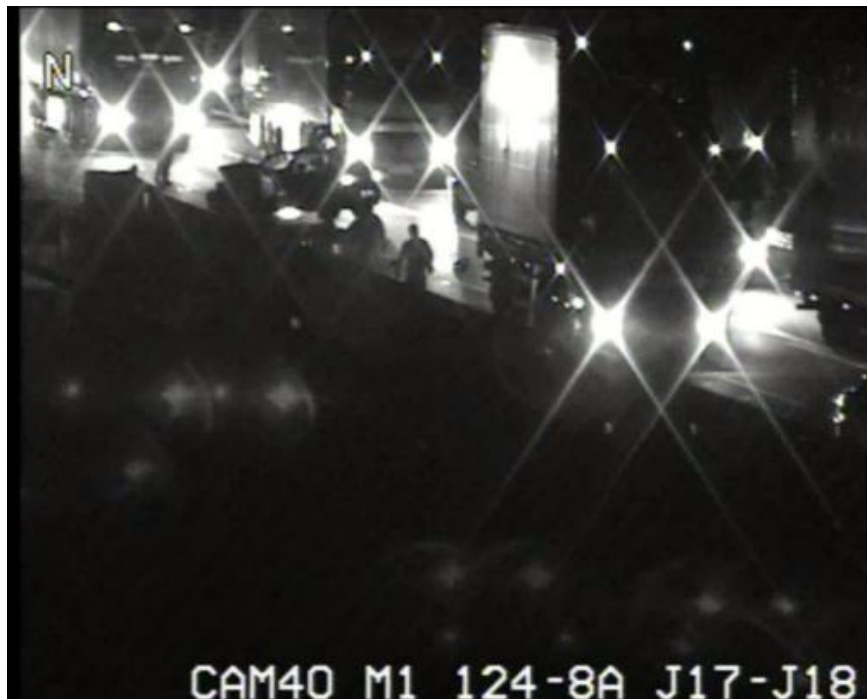
Time: 01:37:01 (GMT) 16/5/2015
 Camera: Camera 40

At 1:36 a VW Polo collided with the crash cushion of the temporary vehicle restrain system.

Photo.1 Photo showing car after hitting the terminal.

Having reviewed the CCTV footage, the incident is in the far distance and it cannot be determined the exact cause of why the car collided with the crash cushion. However, there is evidence that a vehicle (most likely a HGV) put full beams on prior to car colliding with the cushion, which suggests something occurred as the vehicle approach the terminal, supporting the drivers claim.

Actions taken to prevent re occurrence: Continue to ensure crash cushions are used on temporary VRS terminals as per guidance hierarchy of consideration for terminal ends on temporary restraint (if a ramp terminal had been used the incident could have been far works) Continue to support and install the M1 J15 to J42 Customer Experience Programme (Orange corridor) - includes PVMS & education signage aimed at the travelling public Feedback into Highways England on-going roadwork safety campaign.		By who CJPB	By when On-going
		CJPB/DT	15/06/2015
		CJPB	22/05/2015
Name of person reporting near miss:	Christopher Puttrell	Position:	TM Manager
Please distribute to:	Business unit manager/ Area health and safety advisor/ Director, Health and Safety

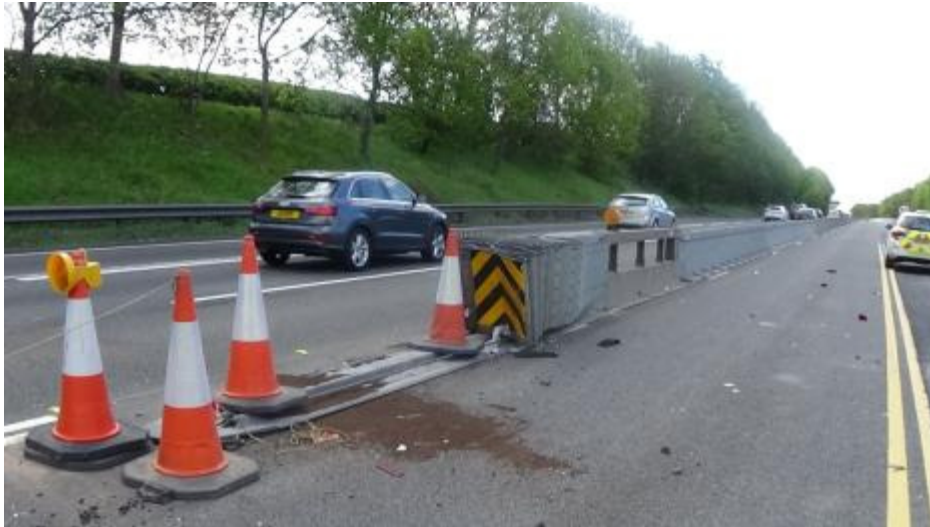
Photo.2 Damaged Crash Cushion terminal

Having recovered the vehicle, the driver of the VW Polo claimed she has been pushed into the temporary VRS Crash Cushion by another vehicle. No injuries sustained.

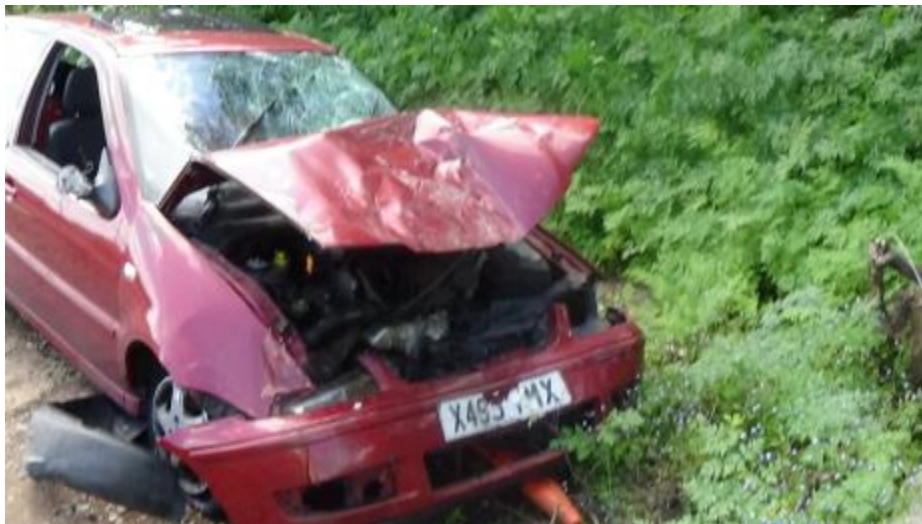
Photo.3 Damaged vehicle (note this was taken once the vehicle had been removed from the network)
