Highways Safety Hub Team Newsletter

March 2021

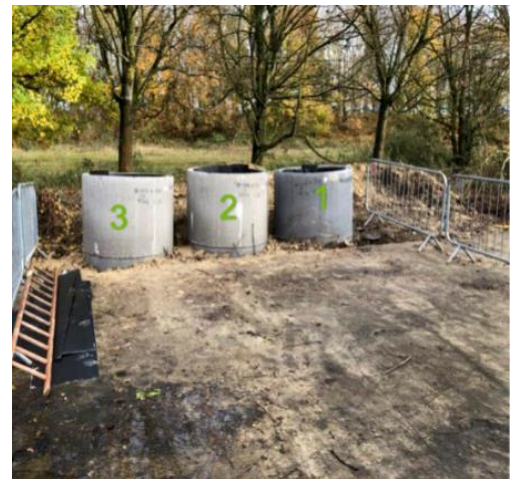
A team led by Deon Louw from the piling specialist Cementation Skanska and Lee Piper the works superintendent, which included the design house and subcontractor Hercules Services have devised a method of pile reduction that means there is little or no physical breaking required. The method involves the reduction of the pile caps when the concrete is wet using a vacuum excavator to easily reduce the pile to the correct height.

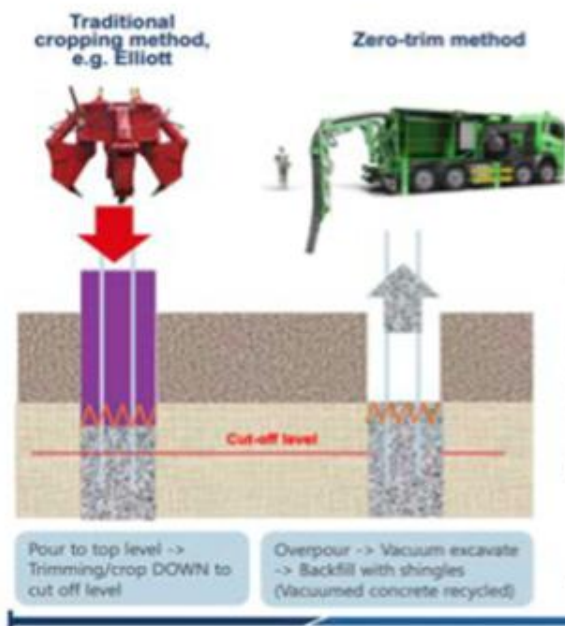
No repair on reinforcement needed
	No noise from drilling and breaking – reduced risks to workforce and stakeholders
	No lifting of equipment required
	H&S Risks associated with hand cropping eliminated – HAVS, confined space, silicosis, working at height
	Integrating capping beam reinforcement made easier
	Benefit of Vac Ex for other high-risk utilities activities

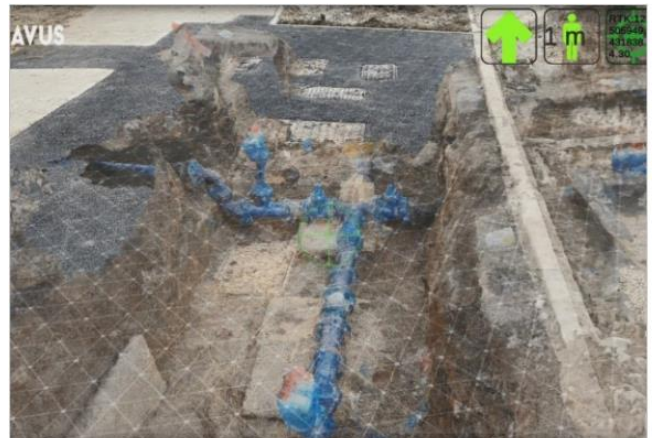
The resulting footage is used to create detailed 3D point cloud models ensuring accurate visual records and 'x-ray vision' of the work completed, utility layout and geology for future works.

The initial trial was successfully conducted by a Morrison Utility Services team working on a bypass and pressure relief valve (PRV) installation in Roehampton, South London.
