Safety Alert

Cropped pile cap rolled into live carriageway

24 September 2021

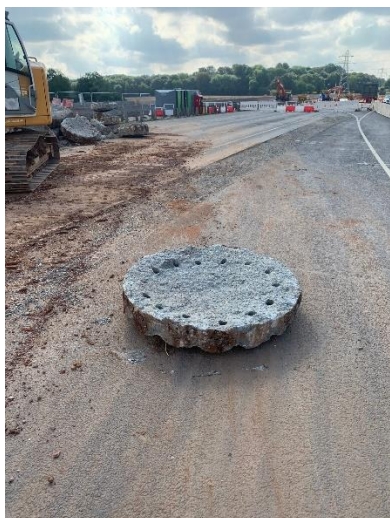
Cropped pile cap

On Saturday 18th September a 1200mm diameter pile was cropped using an excavator and cropper attachment. The cropped section was then placed on the ground nearby. Adjacent to the works was a works access which had been coned to prevent it being used ahead of it being closed with a rigid barrier system.

After it was placed on the ground, the cropped section of pile then became unstable such that it rolled slowly like a wheel. The pile section rolled through the gap in the rigid barriers on to the live carriageway. As it came to a halt it fell to the side and made contact with a car driven by a member of the public.

1. Objects should be placed on the ground in a way which means that they cannot become unstable or mobile for any reason.
2. Where works are undertaken next to live traffic, the risk assessment should consider the risk of equipment and materials entering the live carriageway and include appropriate control measures.
3. All incidents should be reported in line with the [Osborne Infrastructure Limited reporting process](#) and relevant customer requirements.

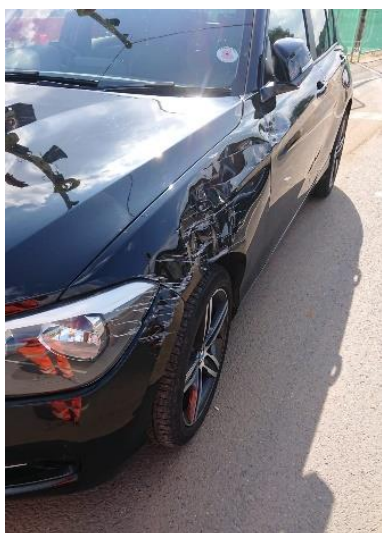
Damage to vehicle

- There were no injuries.
- The car sustained damage to the near-side front wing and front passenger door.
- There was potential for a much more serious incident to have occurred,
