Safety Alert

Network Defects

4 February 2022

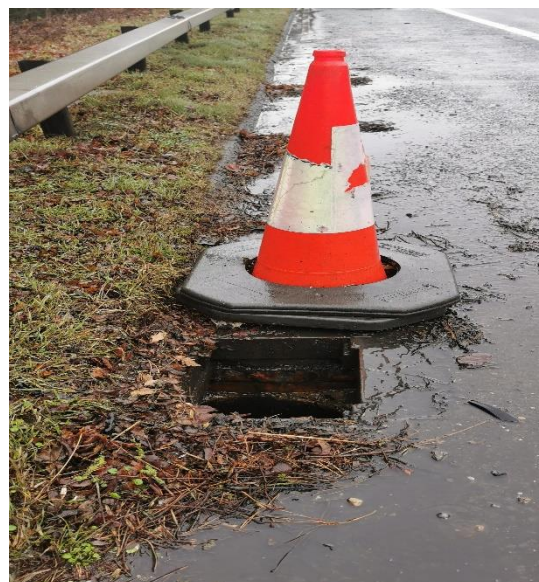
A National Highways Traffic Officer suffered an injury to their right leg and knee after moving a traffic cone and falling into an exposed gulley chamber. The traffic officer was attending to a broken-down vehicle on an at grade over bridge on the A1(M). The traffic officer moved the cone by attempting to push/slide it up onto the verge, whilst doing so, they stepped into the location where the cone had been. The cone had been placed by an unknown person on top of a defective gulley chamber without a cover. This defective gulley chamber had NOT been reported to National Highways.

- The traffic officer was not aware that cones are used to mark / identify a range of network defects
- The defect had NOT been reported to National Highways
- The current highways inspection approach does not include checking single cones on the network
- An unknown person has placed the cone on the defect and not reported it

- Supply chain to be aware of the process for notifying defects on the network (in the first instance - **contact the Regional Operations Centre (ROC) and report defect and its location**).
- National Highways is reviewing the network inspection regime to include further investigation of single cones placed on the network.
- National Highways is reviewing the method used for marking defects on the network, ensuring adequate protection of the defect.
- When working on the network, ensure due care and attention is given to your surroundings AND any task you are undertaking. Remain vigilant at all times.
