# Safety Alert

## RIDDOR Injury - Drainage Pressure Testing

24 October 2022

**Balfour Beatty**

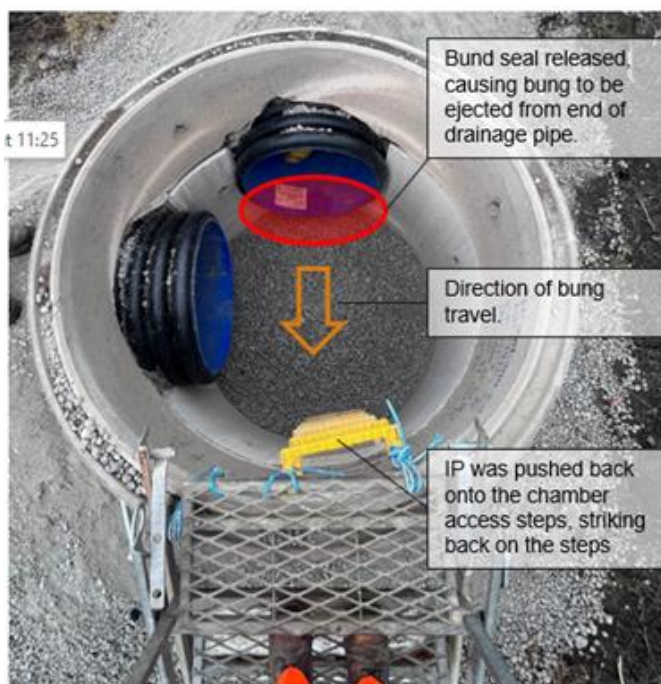
During the air-testing of a drainage installation operation, an operative released the pressure in the installed bung seal prior to releasing the pressure in the pipe run. The bung was ejected from the pipe knocking the operative off balance where his back impacted against the access step rungs in the chamber resulting in a fracture to his T12 vertebrae.

- Equipment to be inspected and tested
- WPP to be amended to include details of pressure testing
- [no further air-testing to be completed until WPP updated]
- Organise training for this equipment
- Review of BMS and make recommendations for this activity
- Review of design recommendations for BS EN 1610 and pressure test requirements for a gravity fed drainage system
- Safety Alert to be produced, approved and issued to NH
- Just Culture Review if deemed applicable
- Review ways to undertake on-site pre-use testing & calibration frequency of equipment

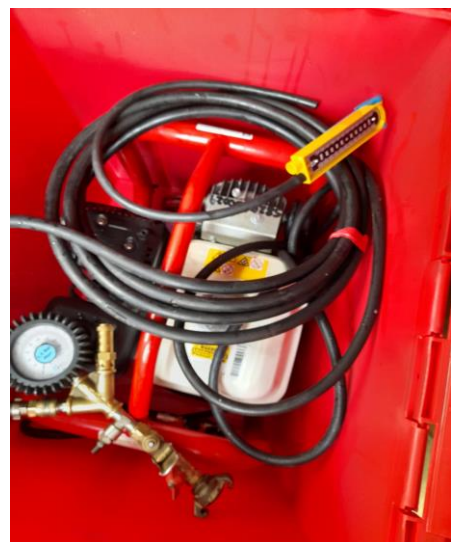
- Equipment being used – VP pressure testing kit
- Location - Ebbsfleet roundabout
- Work activity – Gang were installing a 750mm surface water drainage pipe
- The excavation work was stopped due finding an uncharted pipe crossing the drainage alignment.
- Foreman decided to pressure test a previously laid section of pipe.
- Foreman gave gang a second briefing
- Whilst pressurising the pipeline it was noted that there was no reading on the pressure gauge.
- The air pressure from the bung seal was released before the pressure in the pipeline.

Gauges & Compressor supplied

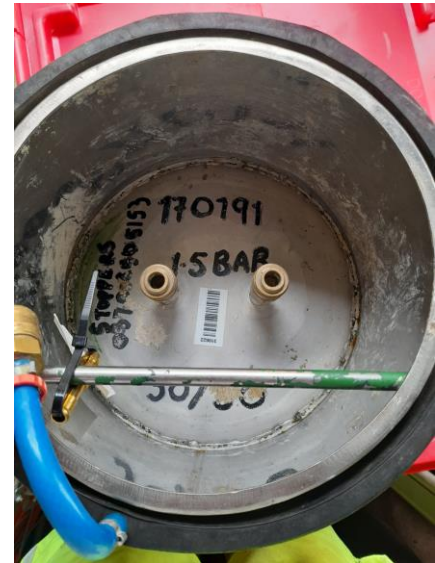
Pipe Bung/stopper
