Safety Alert

Tractor Trailer Towing Incident

6th January 2023

NCA – Mulberry Park

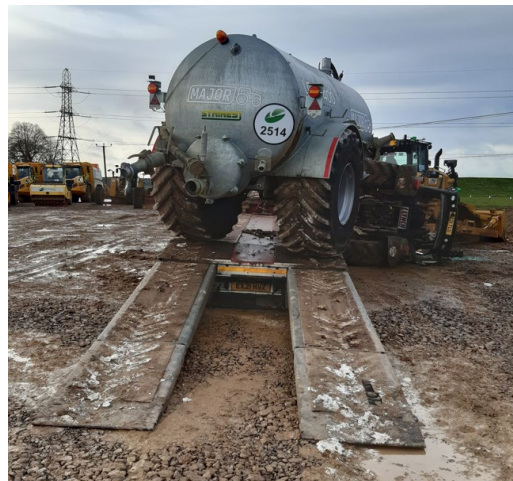
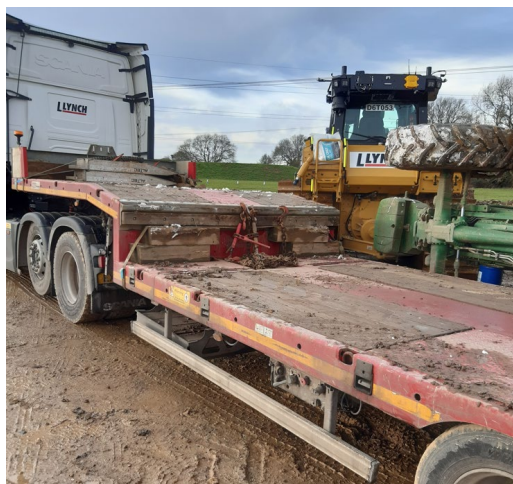
A sub-contractor arrived at site to collect a tractor and towable tanker.

The tractor and tanker were being loaded and due to their combined length, the front wheels of the tractor needed to be positioned on the raised section at the front of the low loader (the swan neck).

Whilst driving up onto the swan neck the tractor deviated from the low loader and toppled to the ground coming to rest on its right hand side.

- Tractor/trailer was being loaded by the sub-contractor lorry driver
- The tanker was empty awaiting collection
- Ramps (for the access onto the swan neck) were in the stored position at the front of the low loader
- The tanker remained attached to the tractor and remained upright on the low loader trailer bed
- No injuries were sustained

- All planned plant deliveries/collections cancelled pending outcome of investigation
- Recovery plan is being developed
- D&A tested of the driver was negative
- An investigation has commenced

- Plan all plant deliveries and collections from site
- Supervise all plant deliveries and collections from site
- Carry out a PoWRA for the area
- Ensure a restricted area is in place (i.e. barriers/segregation)
- Ensure loading and unloading operations are undertaken by trained and competent personnel in accordance with SSoW
