Safety Alert

Placement of the “Workforce in Road SLOW” Sign (Diagram 7001.3)

28 March 2023

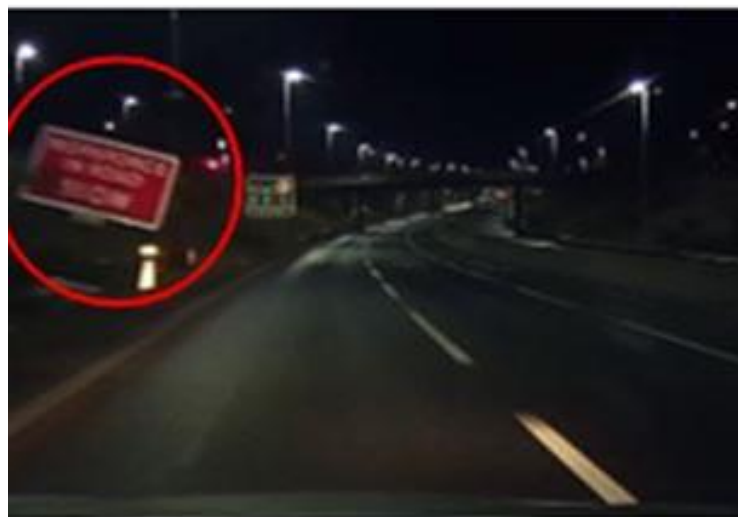
The survey covered all providers and regions and identified that Temporary Traffic Management (TTM) providers are erecting “Workforce in road—slow” signs at locations that require the TTM vehicle to be parked in a live lane.

The condition of many of these signs was also noted as having a poor or extremely marginal sign face condition with substantial numbers being well below the size required by TSM Chapter 8 Table A1.2 and some not complying with the requirements of the TSRGD 2016.

Example of incorrect sign placement

We would like to remind all providers that this sign needs to be erected from a safe location, hard shoulder or lay-by. This must be done before any vehicle enters a live traffic lane to install, maintain, or remove traffic management when using dual vehicle working. This sign essentially forms part of the advance signing for traffic management tasks.

- Signs should be inspected and cleaned regularly to make sure they are fit for purpose.
- Unclean or worn signs do not have the same level of retro reflectivity and therefore do not appear as bright or visible.
- Installing signs from an unsafe location puts all road users at risk.
