# Safety Alert

## Fitting / Removal JCB 2CX or 3CX Breaker Locking Pin

## Title: Fitting / Removal 2CX or 3CX Breaker Locking Pin

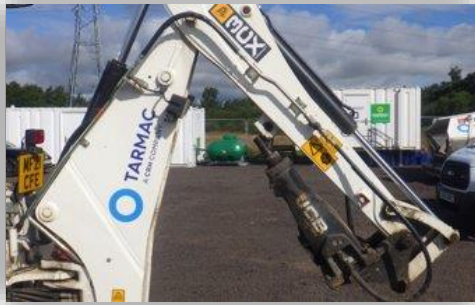
Backhoe Breaker with Locking Pin

- Ensure Guidance for Safe removal / fitting of breaker locking pins for 2CX and 3CX is re-issued and understood by all authorised operators. Link to the guidance is [here](#)
- Ensure all removal or fitting activities of breaker locking pins is carried out in accordance with the Guidance document.

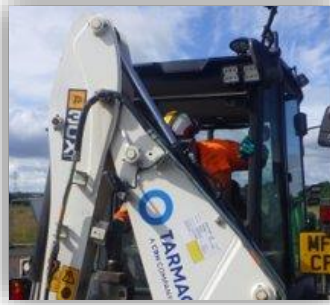
Simulation of Operative attempting to install the locking pin from the cab

- Early indications are that the operative accidentally moved the boom controls whilst attempting to fit the locking pin resulting in an unintentional movement of the boom which caused the injury to the finger. Simulation video of the unintentional pin movement can be found [here](#).
