## M6 j16-19 Overhead structure and service good practice

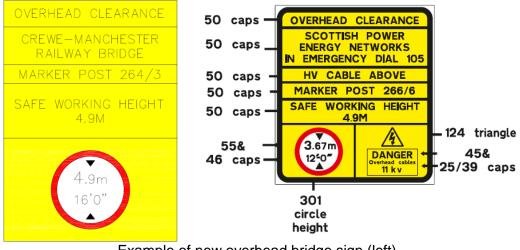
Overhead service protection design work.

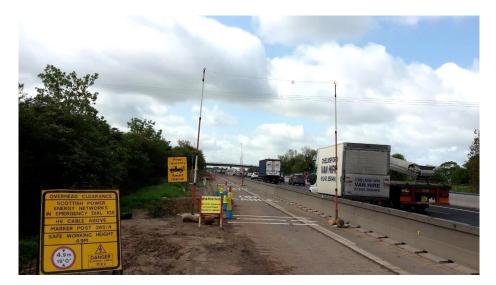
Example of new overhead bridge sign (left). Template for overhead service sign (right).

New signs have been made and placed on site, they state whether it is cables or structure above, outlines the minimum safe clearance height, identifies the marker post location, and emergency contact 'DIAL 105'.

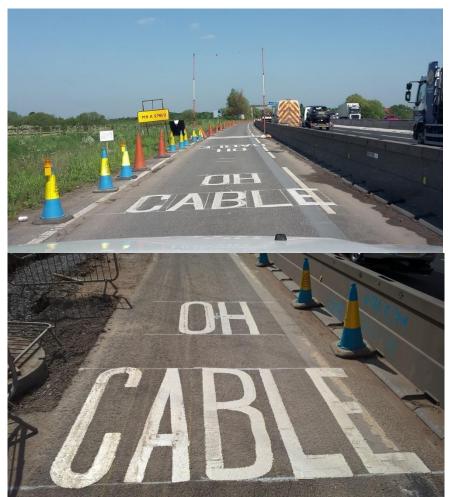
White lining has been used on the ground prior to overhead services reading 'OH CABLE' for increased notification to plant operators and workers about to pass underneath it.
White lining has also been used to create rumble strips underneath some GS6 goal posts.
This causes plant and vehicles to vibrate whilst driving over them, encouraging deceleration and further notification to the driver that they are underneath an overhead service.

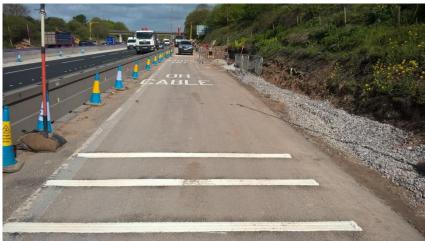
White line rumble strips underneath GS6 goal post.
