A14 Cambridge to Huntingdon

Under Bridge Revetment Paving RIDDOR Incident

PDWG Presentation - October 2019

Paving of Revetment Slopes Under Bridges

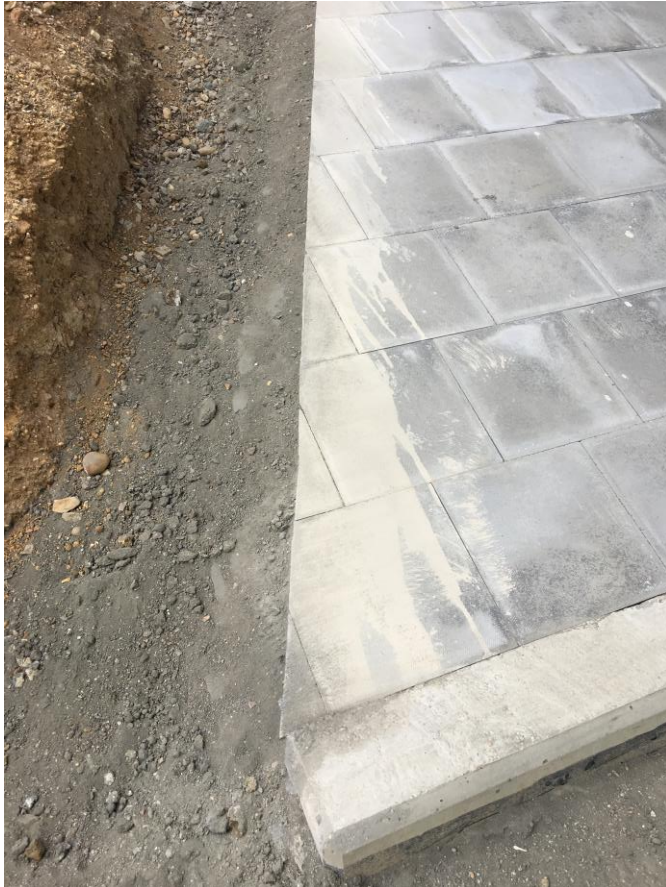
<p>Re-enactment of the incident</p>

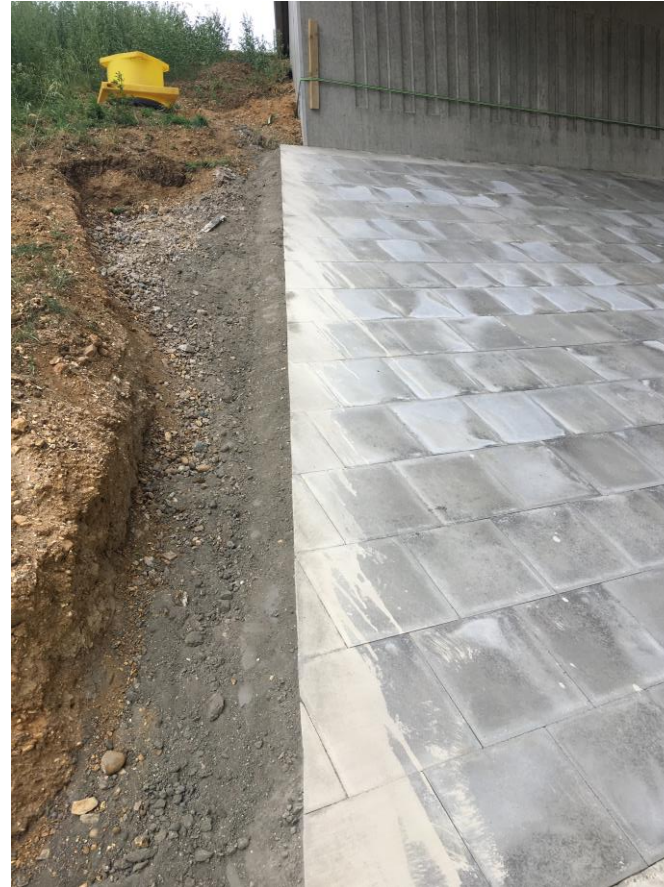
<p>Suspected slab position on operative</p>

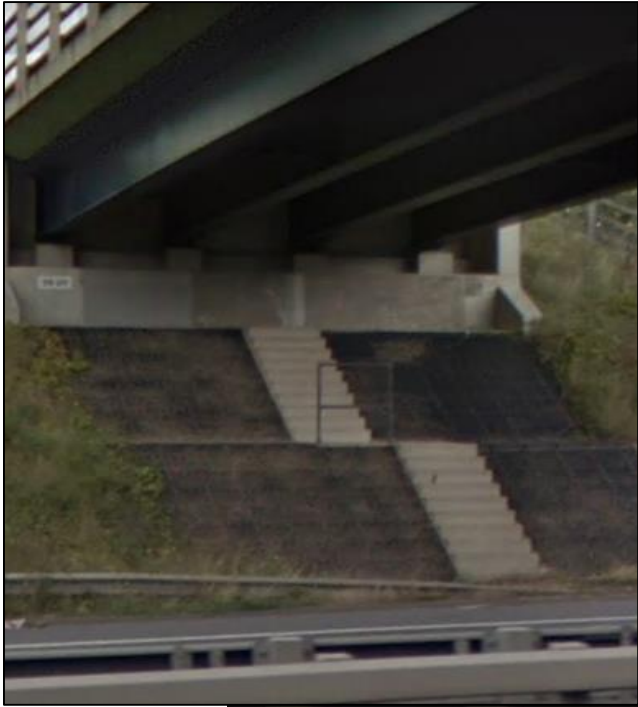
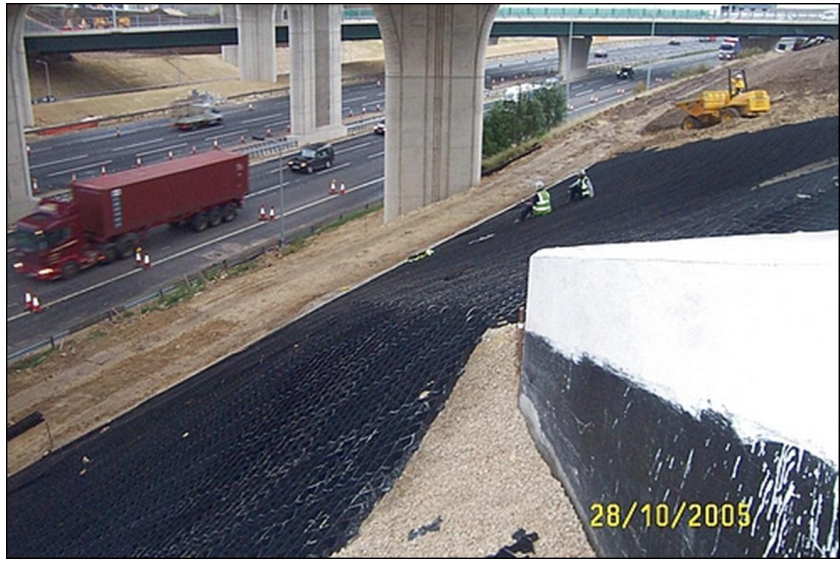
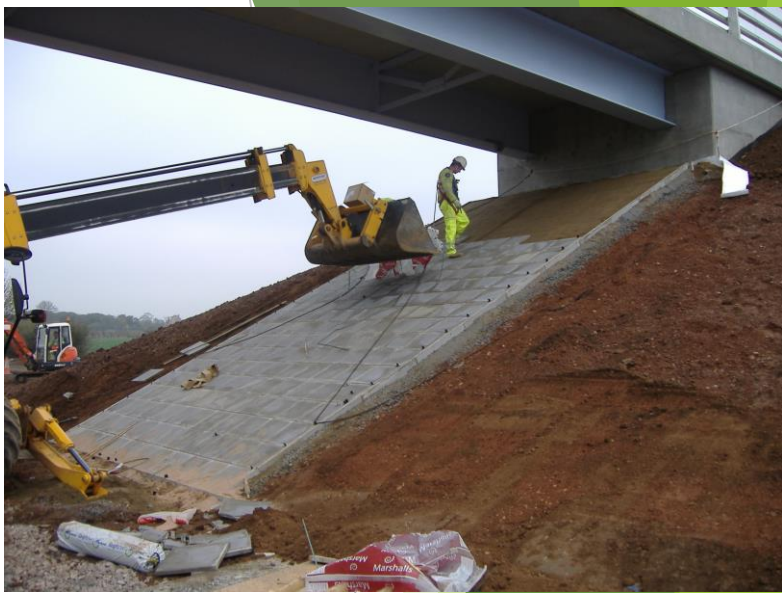
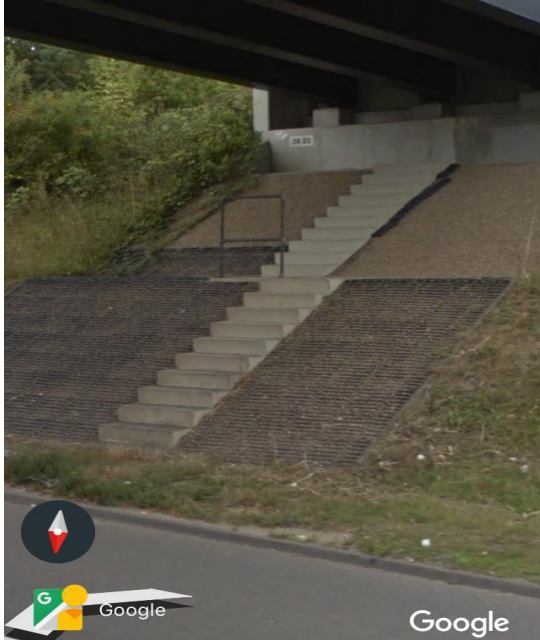
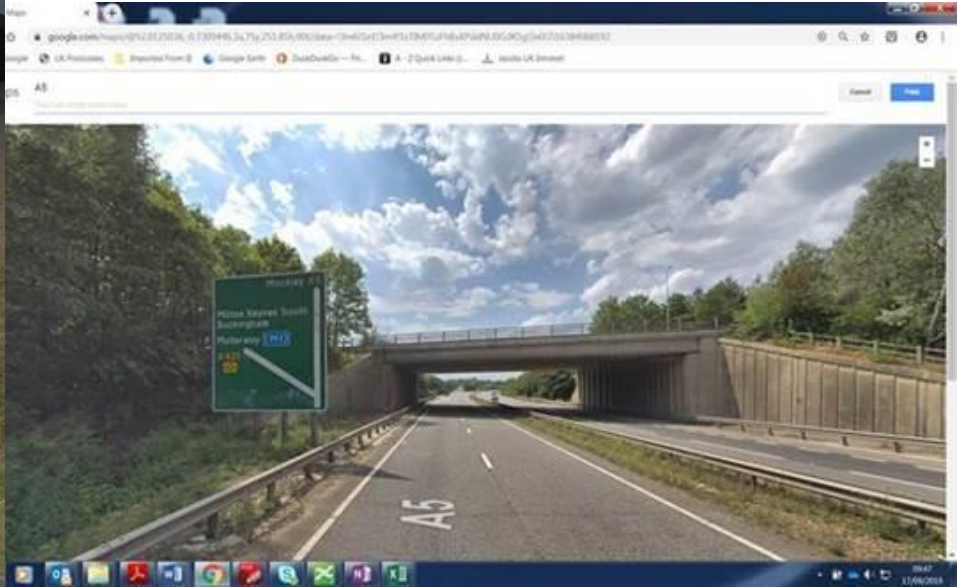
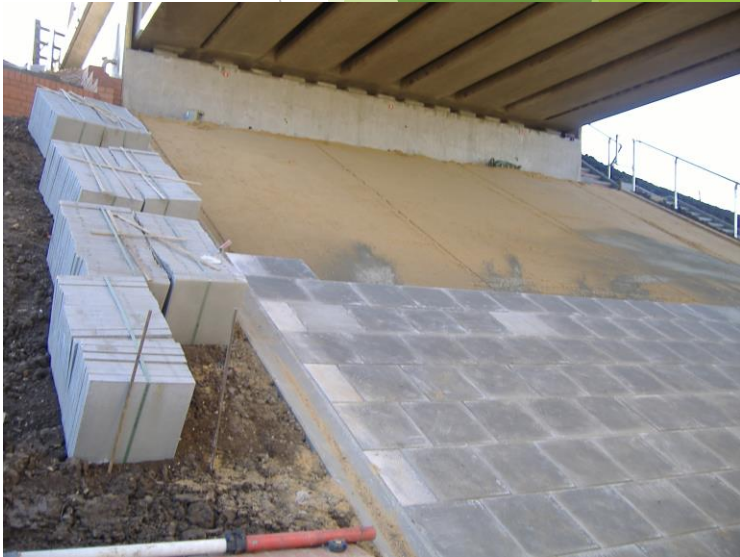
Examples

- Function
- Solutions
 - Slab size
 - Mechanical Laying - Machine control GPS/LPS
 - Plastic products (Fire Resistant?)
 - Grasscrete
 - Geogrids
 - Stone Pitching
 - Gabion Baskets / Matresses
 - Concrete Canvas
 - Sprayed concrete / Shotcrete
 - Sprayed Asphalt
