## Baroness Mulcher Operative Broken Leg

## SafetyAlert

November 2015

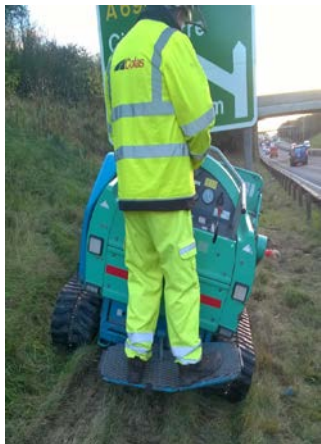
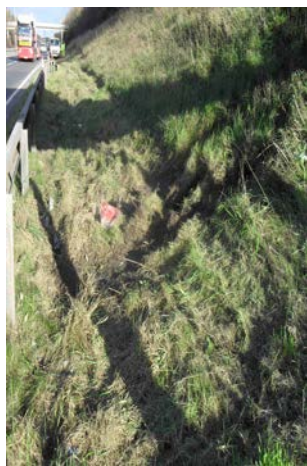
On the 16<sup>th</sup> November 2015 an A-one+ operative suffered a broken right fibula while carrying out soft estate works on the verge of the A1 (T) Newcastle near Fawdon interchange. At this stage of the investigation it is believed that while the operative was using a tracked mulcher he turned the machine and it slipped a short distance (estimates approximately 3 feet) down a gradient and trapped his legs between the machine and the open box beam vehicle restraint system (VRS).

- **Specific to A1 (T) Interchange** - due to the current weather conditions this site has been subjected to A-one+ cannot rule out the ground conditions may have been a factor that has contributed to this event.
  - A-one+ has decided to HALT all activities using similar stand on tracked plant on verges with gradients until further information has been gathered on the investigation.
- Note: Baroness Mulcher is still being used on level surfaces.
- **All other suppliers** - similar equipment used on slopes by the supply chain should be reviewed to assure themselves that works have controls in place to minimise a similar incident.
