Description of Event

Poorly designed and inadequate temporary pedestrian/cycle path access routes during road works.

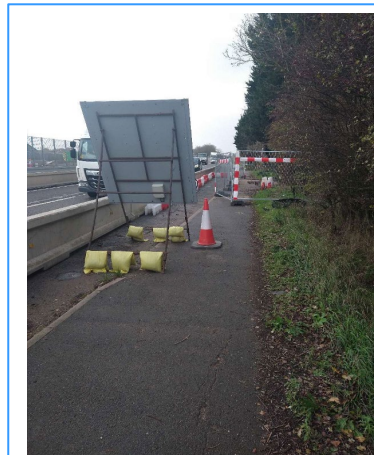
- Temporary access routes did not comply with minimum width requirements and encroached into the VCB safety zones. The routes also contained obstructions including poorly placed Temporary Traffic Management (TTM) equipment and inadequate illumination.
- This has an assessed residual risk of a likelihood of moderate to serious harm.

Photo of temporary access arrangements in vicinity of roadworks.

- Make adequate provisions for vulnerable users and examine the dimensions to ensure contractors can achieve the spacing and safety zones necessary. If not possible, consider alternative routes.
- Human interaction needs with the temporary route proposals should be examined with local knowledge (eg Highway Authority) and more formal RSA and Walking Cycling and Horse Riding assessments considered.

- Walk the provided route to ensure it is acceptable and communicate this with users.
- TTM should not impede access routes, should be reviewed prior to use and maintained.
- Monitor pedestrian behaviour using CCTV and feedback to the designer.

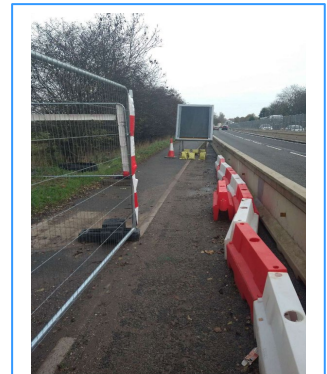
Photo of temporary access arrangements in the vicinity of roadworks.

- Access needs and suitable TTM arrangements should be planned, implemented, and maintained.
- Add best practice TTM to H&S file.
