# EXCAVATION ON SITE – FAILURE TO PROTECT WORKERS

WLD.029

*An excavator was left perched on top of an excavation with the front tracks left hanging over the excavation*

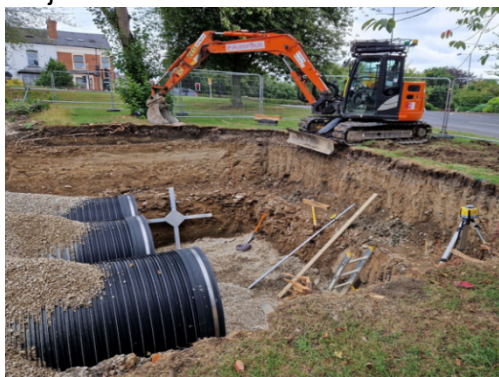
- An excavator working on the edge of an unsupported excavation exposed the plant operator and the ground workers to the potential for a catastrophic ground failure leading to serious injury or death.
- Site Inspector invoked their 'Stop Work Authority' and work was suspended until a discussion was held with the workers to ensure adequate ground support was provided.
- The workers had assumed that the clay ground would be sufficient to support the excavator.

Image showing the excavator perched with its front tracks on the edge of the excavation.

- Consider an alternative storage system.
- Temporary Works Designer should have been engaged to consider the requirement for trench support.

- Contractor to ensure there is competent site supervision.
- The contractor should ensure that the temporary works proposals are prepared by a suitably competent and experienced person.
- All staff should be properly trained and be prepared to 'stop work' in the event that any form of unsafe activity is being carried out.
- Ensure that work is always properly planned and that the correct plant and equipment are supplied to ensure that the health and safety of all workers are considered at all times.
