Material failure to Dipper Arm of an 8T Hitachi Excavator

Incident Description

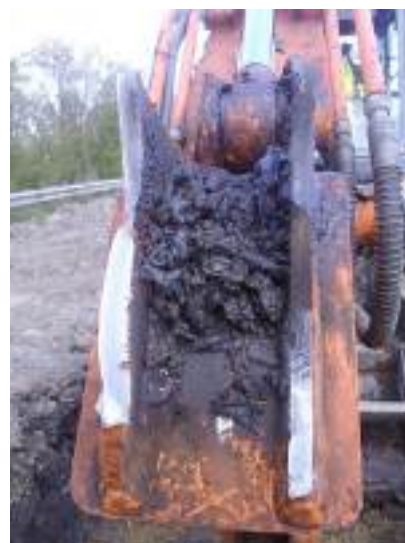
The excavator, fitted with a ditching bucket, was excavating a shallow trench when the lugs of the front dipper arm sheared (at top arm cylinder bracket – refer to photos below).

Initial (visual) investigation has suggested steelwork material failure (fatigue) to the lug/s **(Not the welds)**.

- The Excavator was stood down immediately, and has been removed from site. No-one was injured.
- As a further precaution, another 3 Excavators of this type on site have also been stood down and further inspected. No visible deterioration was found.
- Hitachi Construction Machinery UK (manufacturer) was contacted, and in response:
- They provided a “Product Alert” issued by Hitachi in April 2016 relating to their having received several reports of fractures in arm cylinder brackets, which have gone unnoticed and eventually resulting in total separation due to fatigue.
- Representatives from Hitachi visited site to view the damage on Mon 09 May 2016, and their investigation to determine causation is on-going.
