Safety Alert

Bomag Roller Drum Incident

13th June 2019

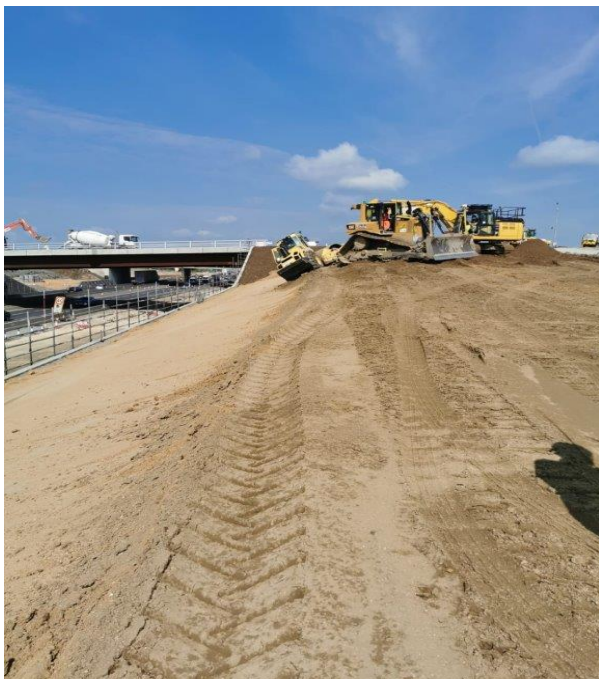
On the 20th May 2019 whilst undertaking fill and compacting operations on a bridge wing wall on the A14 project in Cambridgeshire - a 12 tonne Bomag BW216 drum roller partially slid approximately two metres down the sloped sand bank of the wing wall and remained in its upright position. Works in the area ceased and the area was made safe.

- The procedure states that the slope/batter must be overfilled by 500mm, this by nature would create a bund and keep the machine away from the slope / batter edge. This was not completed.
- The supervisor had responsibility for supervising 20no machines operating over a 400-metre area. This was considered inadequate for the levels of supervision required for individual tasks.
- The task risk assessment states in the control measures that a minimum distance of 0.5 metres must be kept from the slope / edge when rolling. This was not adhered to.

- The incident was briefed out to the teams with immediate failures identified. All raised access egress areas must comply with the Project Directors mandate for bunding.
- Review of Supervision levels was completed.
- Bunds were constructed in all other areas where raised bunds were required.
