SERIOUS INCIDENT EVENT REVIEW

Incident Description: Load fell from Flatbed when leaving site

Incident Date: 08.12.2020

2600-TDWAY-TTTUN-990-ZZ-PF-700007-P5 ▪ OFFICIAL ▪ Approved Status: Approved

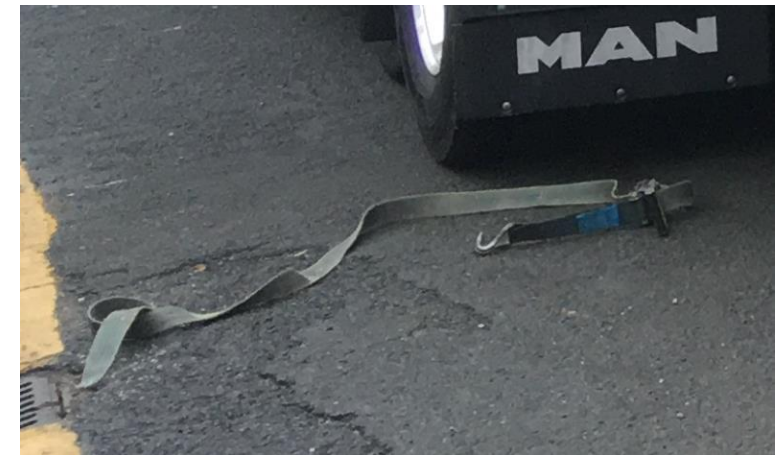
Photo taken at 10:17

Strap snapped

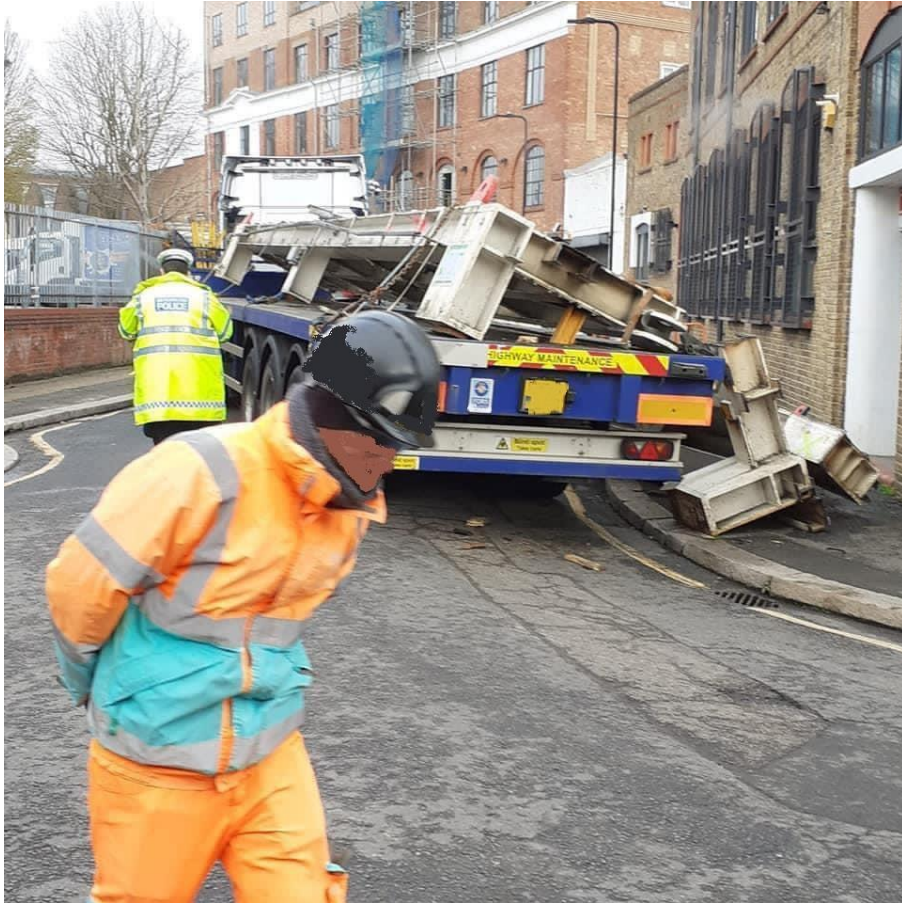
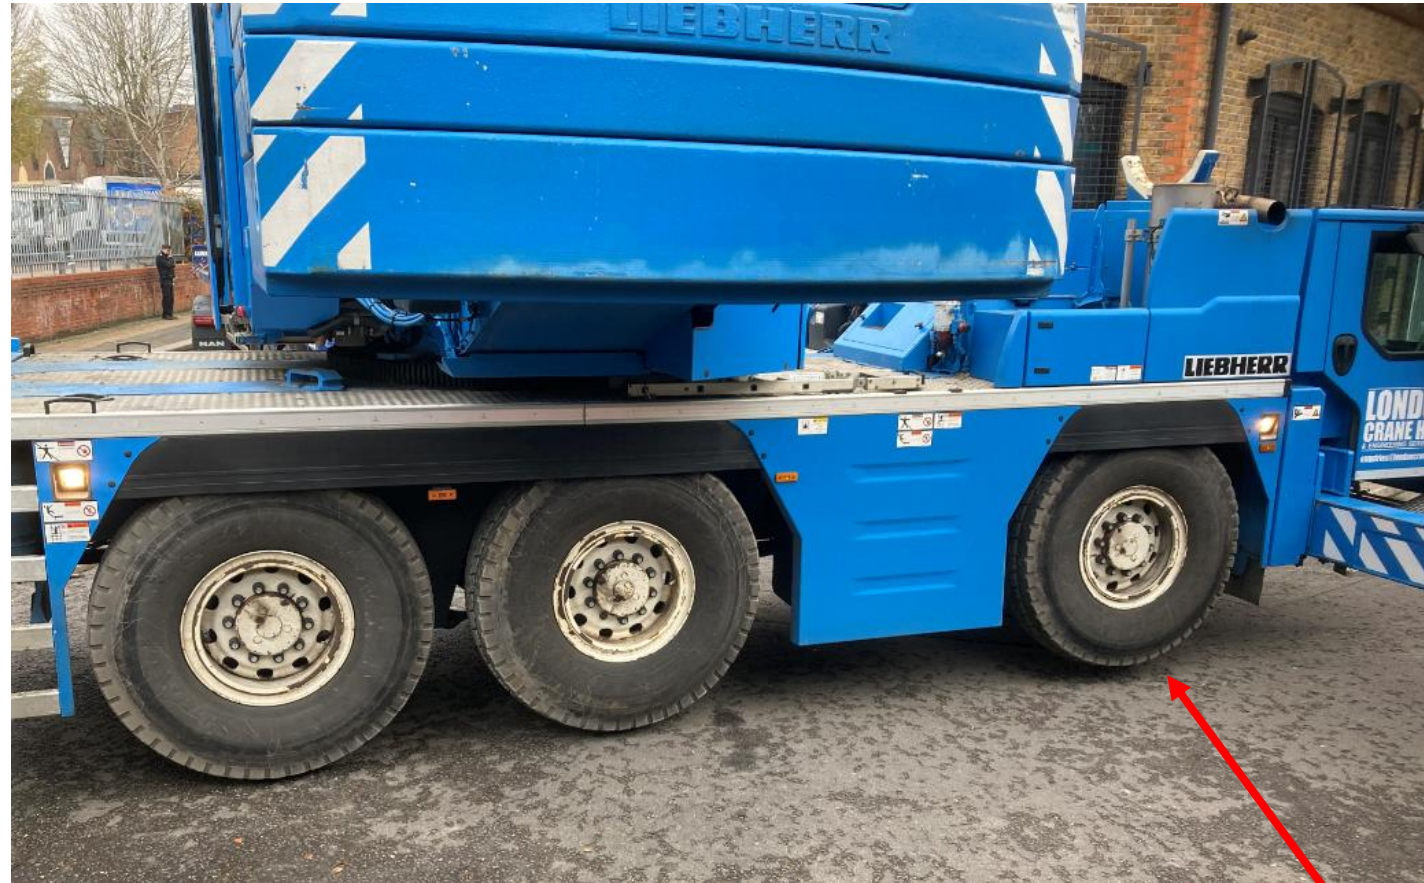
Other factors

CAMBER IN ROAD

- When the wagon mounted the kerb, this “shock load” caused some part of the loaded stack to shift, also causing the chains to move and potentially loosen.
- When the last wheel came off the kerb, the drop in height with the camber in the road caused the weight to shift, punching through the flat bed.
- Each section should have primarily been with chains and the straps should have protection on.
