TECHNOLOGY **Cabinets and Signal Posts**

1500.001

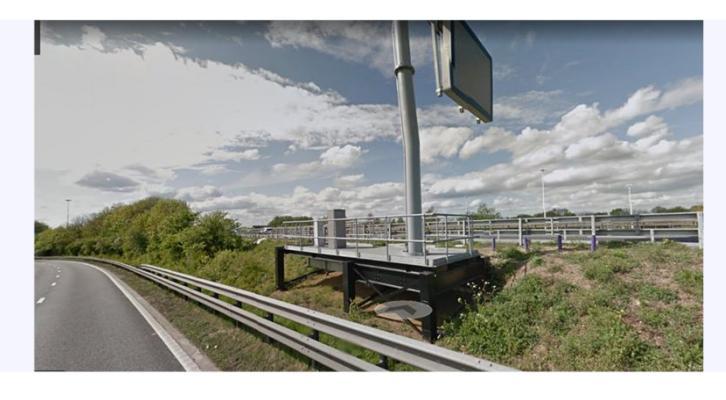
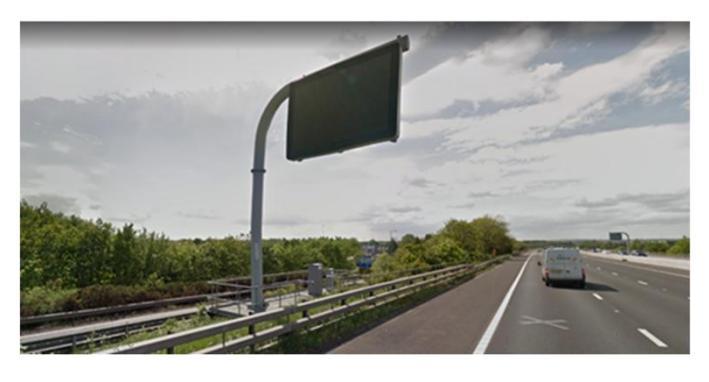
Case Study

In this example the sign gantry and communications equipment is mounted onto a grillage on the motorway batter. This gantry is also located between the main carriageway and an off slip. Grillages are classed as structures and therefore require 2-yearly general (visual) and 6-yearly principal (touching distance) structural inspections. The area below the gantry is classed as a confined space and access into this area is difficult.

Most grillages are located on steep embankments and are difficult places to work. The embankments may be classed as too steep to work on.

Where feasible, provide access for maintenance workers to mitigate risks during inspections. Consider enlarging the spaces beneath grillages to reduce confined space issues.
