LANDSCAPING Access for Maintenance Activities

Case Study

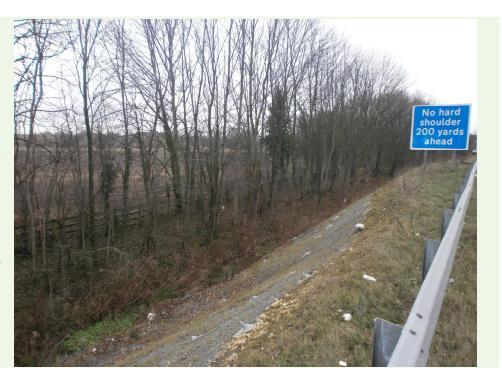
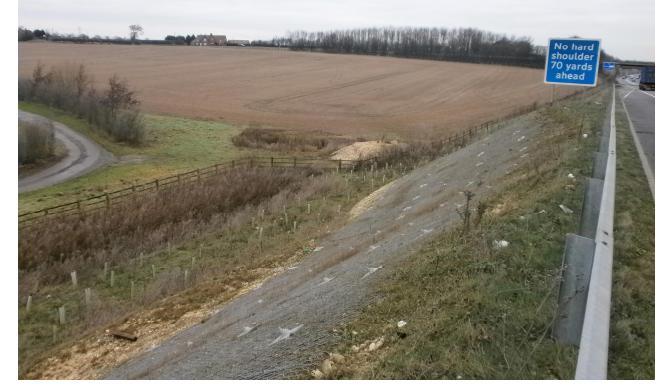
The examples in these two photographs show how, despite the embankments having been steepened, there has been negligible residual width provided for landscaping. Whilst a design solution may appear to be acceptable when first planted, as shown in the photo below, within a few years the situation can be very different when planting matures, as above.
