### Issue

Accessing technology equipment for inspection, testing and maintenance is required on a regular basis. Failures with equipment can result in non-compliant signage of traffic regulation orders such as speed limits and 'Red X' indicators. It is important that safe access routes are provided for efficient operation and maintenance.

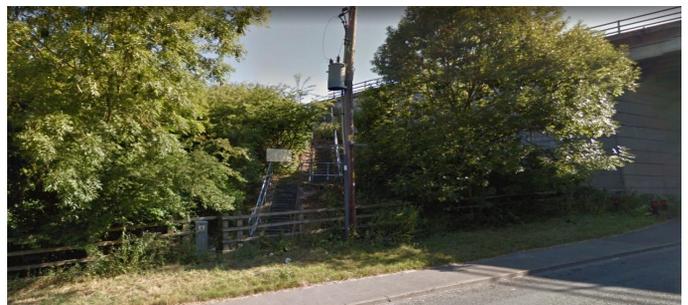
In addition to routine inspections, there is a relatively high frequency of site visits required to communications equipment faults compared with standard civil and structural engineering elements. Additionally, this can impact on traffic regulation if mandatory signage such as speed limits and 'Red X' lane closure indicators are not displaying. One solution is to place some elements adjacent to off-network access points such as local side roads. The image below shows a cabinet located on a side road with access to maintain the mainline's technology cabinet located at the highway boundary.
