Delivery Driver Fell Whilst Exiting Vehicle

Overview

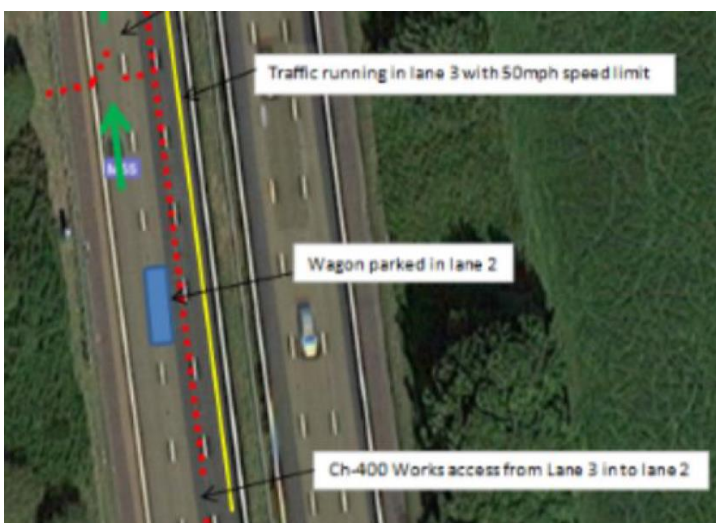
- It is unclear if the driver applied the correct 3 points of contact when exiting his vehicle.
- The delivery driver did not wait in the correct holding area as detailed in the night map.
- The position of the vehicle was too close to the cones to allow for a safe exit without encroaching into the 1.2 metre safety zone.

- Drivers and passengers to apply the correct 3 points of contact technique when entering/exiting their vehicles.

- All drivers must follow site instructions and the instruction of the on-site Banksman. If there are any problems they must contact the site Supervisor or Banksman.
- When on site, drivers must not exit their vehicle unless they have been given clear information on where the safe areas are located or when instructed to do so by site personnel i.e. the Banksman.
- Site plans to ensure that areas are clearly shown where vehicles can be safely exited and the 1.2 metre Safety Zone is maintained.
