<b>Form Ref:</b> HSI-10	<b>Independent Health &amp; Safety Inspection – Blue Star Item</b>	<b>Version: 2.0</b> Jun 2015
----------------------------	--	---------------------------------

<b>Project</b>	<b>Principal Contractor (PC)</b>	<b>Date of Inspection</b>
A27 Falmer Footbridge	Balfour Beatty Mott MacDonald	12/04/16
<b>Site Contact</b>	<b>Email Address</b>	<b>Telephone Number</b>
Greg MacKinnon	<a href="mailto:Greg.mackinnon@bbmmjv.com">Greg.mackinnon@bbmmjv.com</a>	07580816899

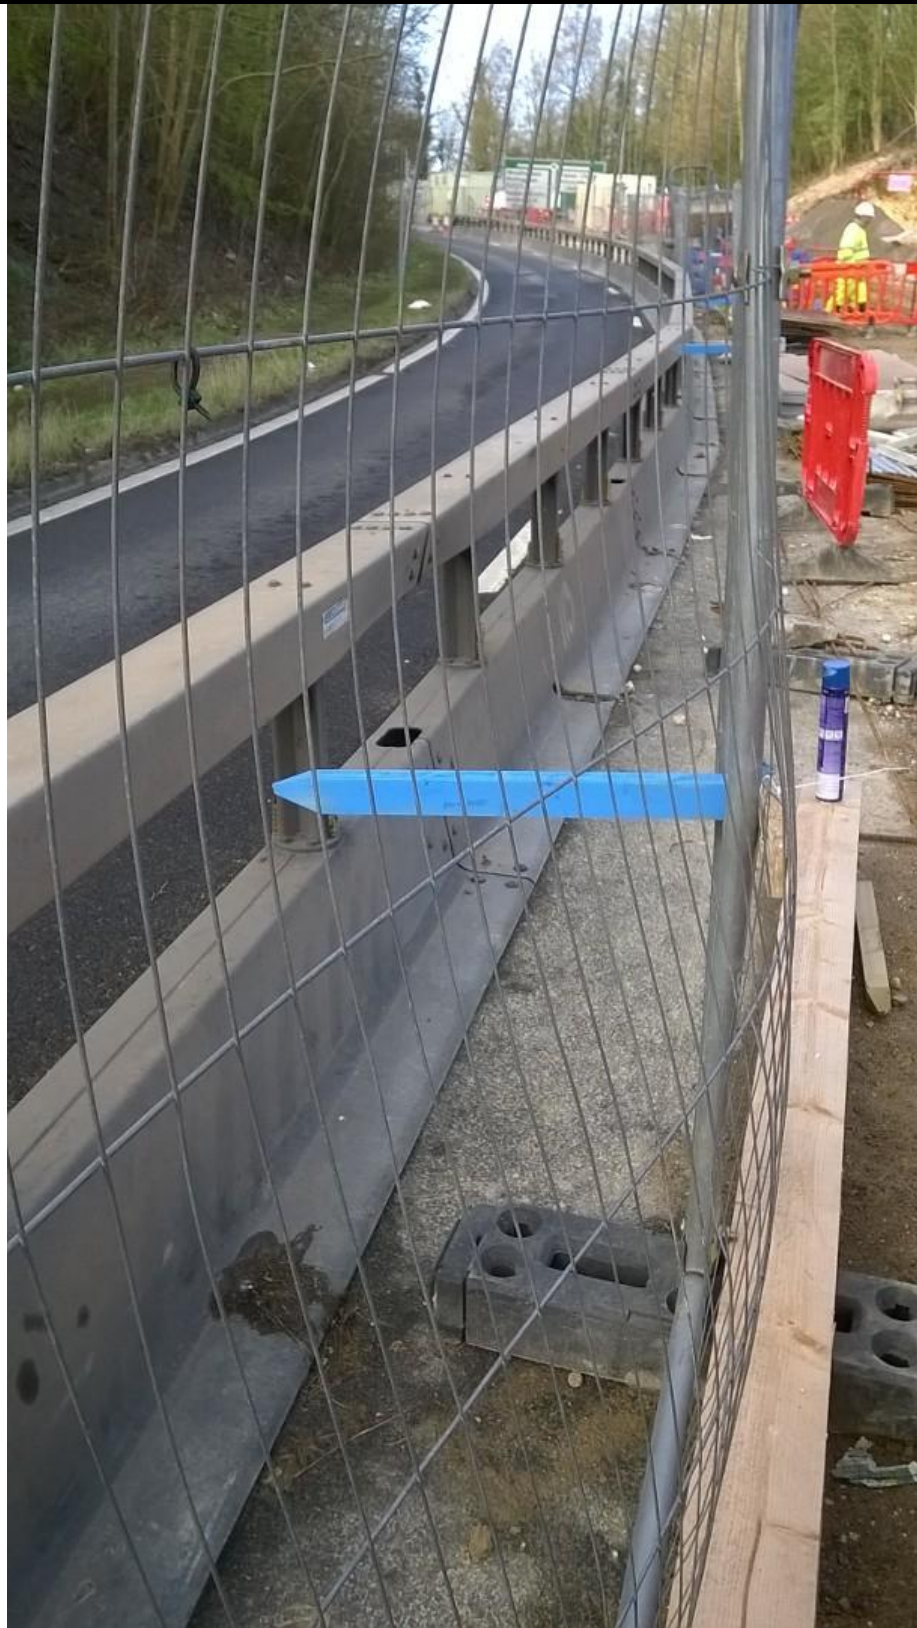
Photograph

<b>Description of Blue Star Item</b>	During construction works, it was noted that our Heras fencing that demarcated the site boundary would often encroach on our 600mm deflection zone and need to be checked and moved regularly. This occurred due to the constraints of the site and how valuable space had become. To counter this we made 600mm long stakes that could be fixed to the Heras fence that would ensure the deflection zone was cleared from any fencing and materials. The stakes were painted blue for visibility. The stakes were made with a base plate that could be secured to the Heras fencing from the inside as to allow instalment and removal to be from a position of safety and with ease for the operative.
<b>Benefits of Blue Star Item</b>	The described item above ensured that no items or fencing would encroach on the Varioguard safety zone which could be hazardous to the operatives on site should there have been an RTC that could project materials or fencing on to site.

<b>Details and Cost of any Specific Product</b>	The stakes and boards were made up on site and did not require much time to create, therefore keeping material and labour costs to a minimum
