Form Ref: HSI-10	Independent Health & Safety Inspection – Blue Star Item	Version: 2.0 Jun 2015
---------------------	--	--------------------------

Project	Principal Contractor (PC)	Date of Inspection
A27 Falmer Footbridge	Balfour Beatty Mott MacDonald	12/04/16
Site Contact	Email Address	Telephone Number
Greg MacKinnon	Greg.mackinnon@bbmmjv.com	07580816899

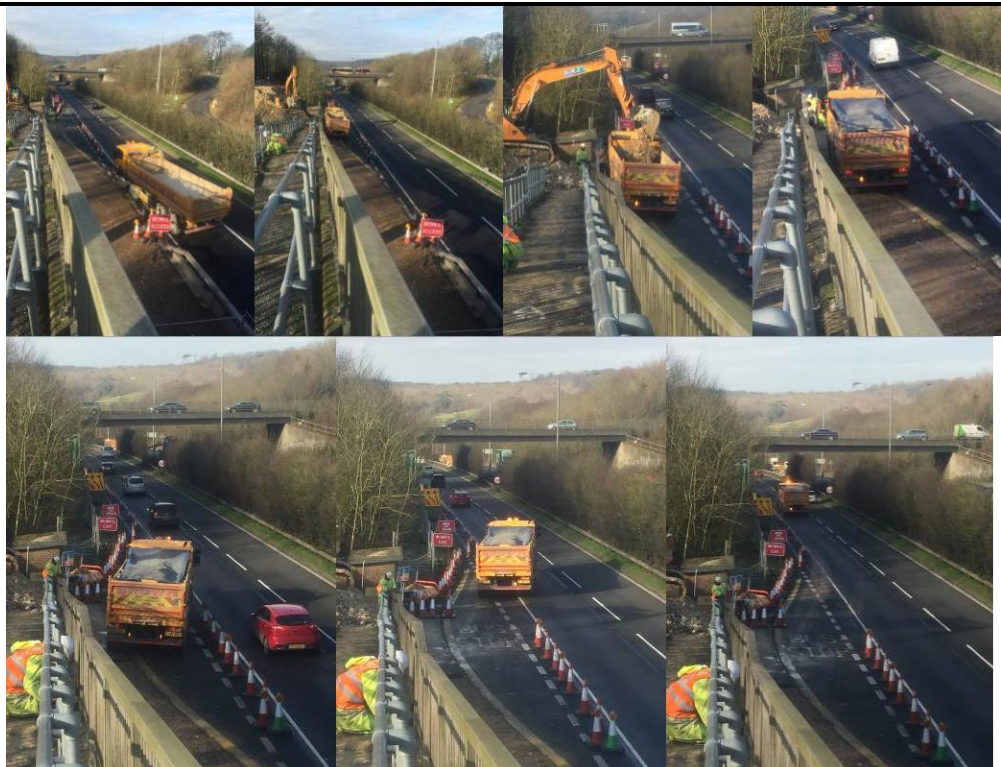
Photograph

Description of Blue Star Item	<p>When planning our muck away procedures, we had very limited space on site, with the curvature of the road not allowing an adequate view for the driver to exit site on the northern side on to the A27, and had a small bus stop available (see picture 1). As the muck away vehicles would be re-entering a high speed road which we had a reduced speed limit on. It was clear that further planning was necessary to conclude a safe system of work. We decided to create a run-on platform by extending the bus stop area with hard standing material and implemented a process into our safe system of work which would be co-ordinated using the following procedure;</p> <ol style="list-style-type: none"> 1. Muck away vehicle will park in a lay by on the A27 2. Traffic management operatives would be stationed at the lay-by and on the existing bridge 3. Radio contact would be made between the two when the site was ready to receive a muck away vehicle 4. The vehicle would pull into the existing bus stop and be loaded, with any other muck away vehicles returning to the offsite lay by to stand by 5. The vehicle on site would then reverse onto the hard standing 6. The TM operative located on the bridge could see all the way down the A27 and advise the driver when the road was clear to exit. 7. The TM op could then radio to the other in the lay by to let them know site was ready for another vehicle to prevent 2 vehicles arriving at the same time <p>This system combined with the additional approach distance we provided was monitored and deemed a safe system of work. This process worked particularly well and allowed us to remove up to 500T of material in a single day.</p>
