Form Ref: HSI-10	Independent Health & Safety Inspection – Blue Star Item	Version: 2.0 Jun 2015
----------------------------	--	---------------------------------

Awarded for Exceptional Performance or New Initiative not widely used on other sites
---	---

Project	Principal Contractor (PC)	Date of Inspection
M1 J19-16	Costain Galliford Try	15/09/16
Site Contact	Email Address	Telephone Number
Eamonn Slevin	Eamonn.slevin@costain.com	01788 520600

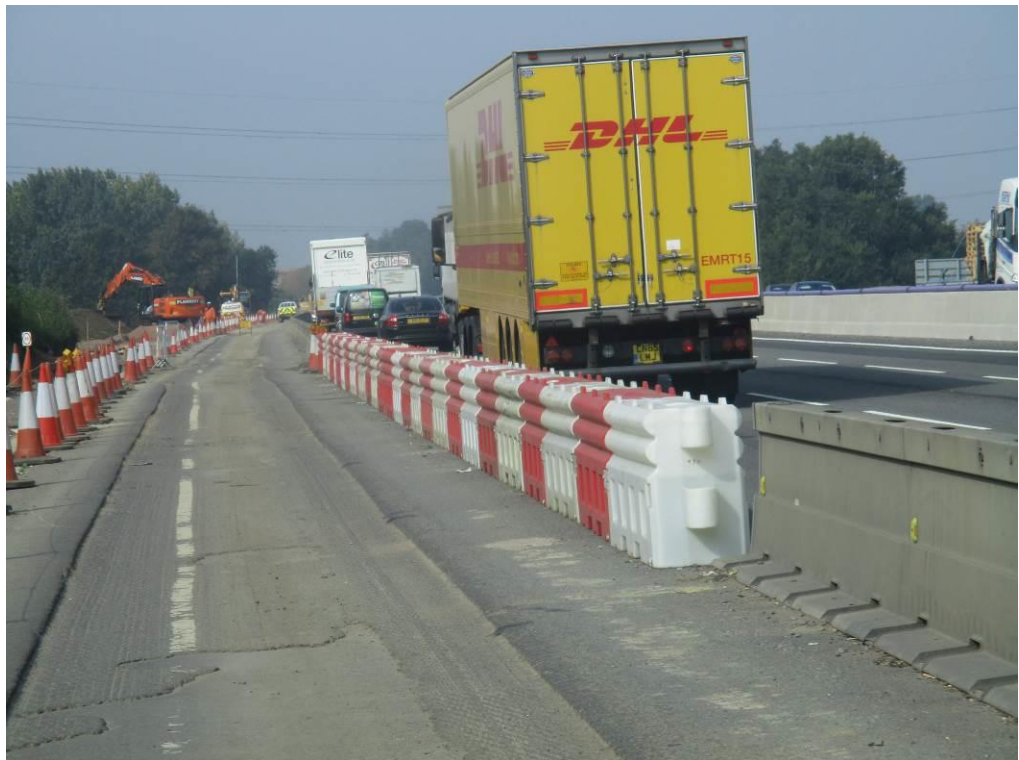
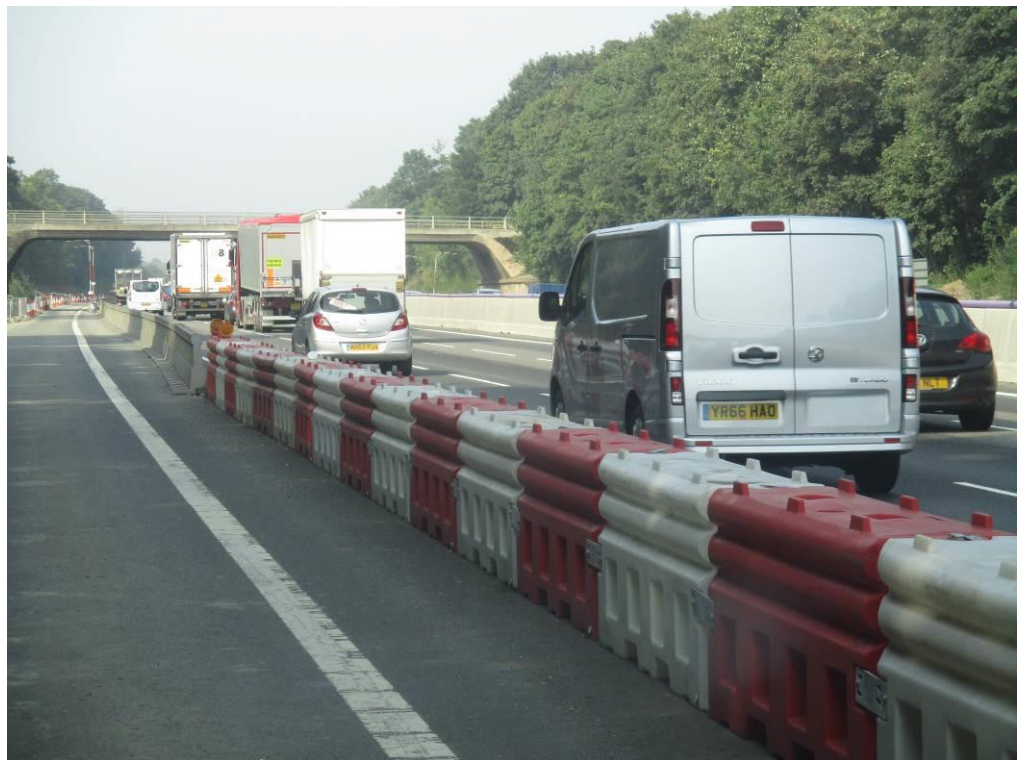
Description of Blue Star Item	<p>The M1 J19-16 contract implements a procedure whereby in order to work adjacent to the live traffic or across an open gap in the Zoneguard, there must be a physical barrier (temporary or permanent) in place or a closed lane separation in place.</p> <p>The pictures below shows a gap in the Zoneguard filled with water filled barriers (Rhino).</p>
Benefits of Blue Star Item	<p>This system means a lower risk of vehicle incursions into the work site and is safer for the road worker.</p>
Details and Cost of any Specific Product
