DRAINAGE and DUCTS – Statutory Undertakers Temporary Works – Excavation Collapse

0500.001

HEi044 – Temporary Works – Excavation Collapse

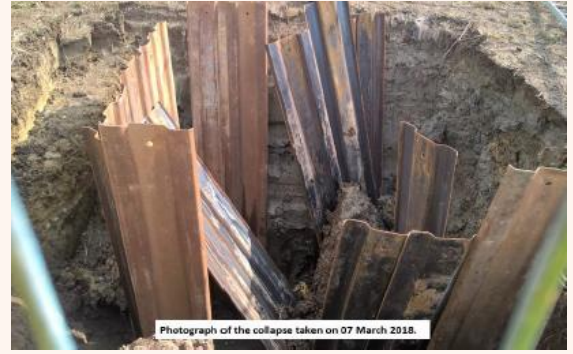
- *Temporary excavation supports were not installed as designed*
- *Lack of inspection by a competent person prior to access/use*
- *Lack of understanding/consideration of the potential impact that poor weather conditions could have on an open excavation*

- Designer to review STATS information
- Could a GPR Survey suffice?
- Implement design clash reviews (3D BIM clash reviews) to avoid STATS
- Ensure Pre-Construction is specific and contains accurate information on ground conditions

- Temporary works shall be installed / constructed in accordance with the agreed design and inspected on completion (and prior to use).
- Inspection by a competent person shall be completed and recorded at the start of each shift, and after any event that may have affected strength or stability, such as heavy rain or following prolonged dry periods or change in traffic management.
- Review check sheet for excavation inspections covers the requirements of Temporary Works

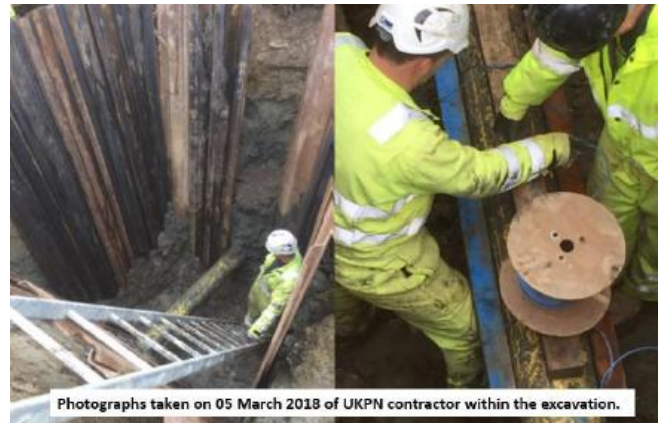
Excavation to expose the services had been completed and steel shuttering sheets were partially installed around the trial hole. However:

- the installation was incomplete
- the temporary works were not in accordance with the TW design
- no pre-access inspections by ‘a competent person’ had been carried out
- there was a lack of appreciation of the impact of the poor weather conditions
