No: NRS 338

## Network Rail Safety Bulletin

### Crush Injury to Slinger / Signaller

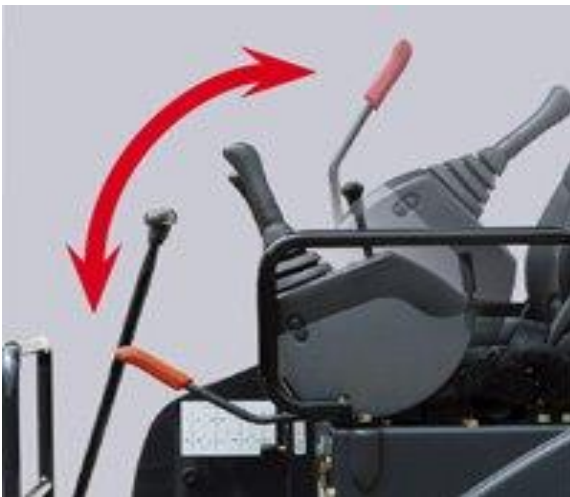
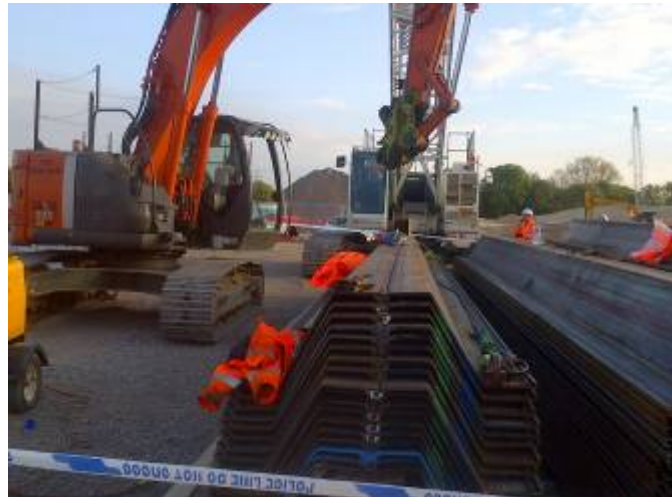
On 2 October 2014 a serious incident occurred on site during a lifting activity. A slinger/signaller was in the process of attaching lifting accessories to the lifting eye of a 22 tonne tracked 360 excavator. Whilst attaching the lifting accessories to the excavator's quick hitch, he came into contact with an unintentional movement of the dipper arm of the machine. The slinger/signaller, positioned between the machine's dipper arm and a stack of sheet piles, sustained serious crush injuries.

- Before work commences, how do you ensure as a machine operator, that the plant you're operating cannot make an unintentional move whilst activities take place with staff within the exclusion zone?
- As a work group, do you always understand and agree the communication protocol that indicates that the load and associated equipment is safe to approach?
- What could be the effect of the slinger/signaller fitting or removing an attachment/lifting accessory to an item of plant before the machine operator confirms the safety lever (dead man's handle) is in the safe position?
- As the machine operator how do you ensure that the dead man's handle is in the safe position when plant is used for lifting operations and accessories are attached or removed?

Remember - Always follow the lifesaving rule "Never enter the agreed exclusion zone, unless directed to by the person in charge"
