Safety Alert

Overtaken Rider on Roller

Kier working on M23 Smart Motorways Scheme

Overturned Rider on Roller

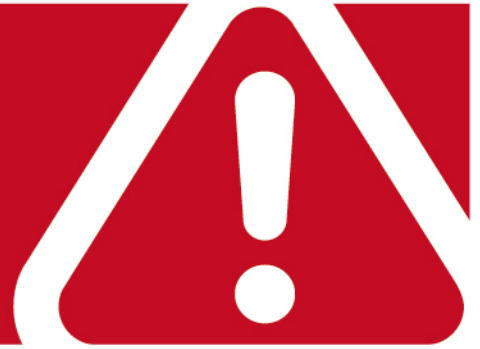
Whilst a piling mat was being constructed, which forms part of the permanent works for an emergency refuge area, an operative was compacting 150mm layers of materials driving a 2.5t, 12D Hamm, 120 ride on roller.

During compaction, the operator drove too close to the edge of the platform and as he reversed back to pass, the back end of the roller began to slip over the edge of the platform. The roller tipped over slowly on its right-hand side with the operator still at the wheel.

The operator was not injured in the incident, he had his seat belt on at the time and therefore did not come off the roller and no part of his body was trapped.

The roller was operating too close to the edge of the platform

No Physical measures were considered or installed to prevent the roller from coming too close to the edge

Direct Instructions to keep away from the edge were not adhered to which were documented in the daily briefing

The SSoW did not mitigate key hazards associated with the work

Do not operate rollers too close to the edges of slopes and embankments

Consider the use of remotely operated compactors.
