Safety Alert

Wire rope breakage

Aecom working on Lower Thames Crossing

Learning From Incidents

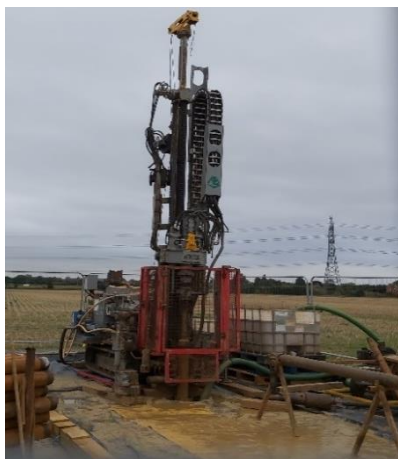
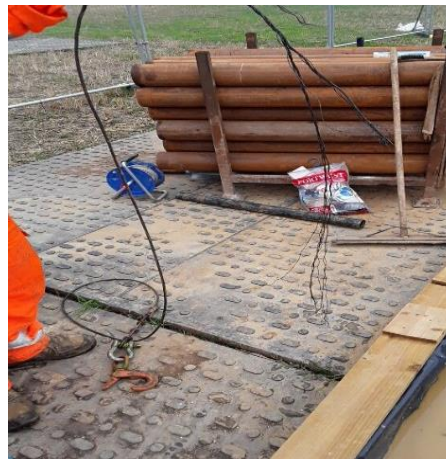
On the 10th September 2019, at approximately 16:40 hrs the Lower Thames Crossing GI team at Package C, working on the north side of the Thames on open agricultural land were undertaking in situ standard penetration testing at borehole location BH13008. The task required the team extract a steel sampling rod from the borehole via the rig winch and wire rope. During the rod extraction the wire rope snapped, and the operation was stood down. No injuries occurred as a result of the incident.

The rig winch was fitted with a 6mm wire rope for the purpose of SPT tests which had a safe working load of 822kg. The winch had a safe working load of 2 tonnes which gave a factor of safety on the accessory as less than zero. The lifting / pull capability of the winch far outweighed the capability / strength of the wire rope which caused the rope to break under strain.

In addition, the safety feature of the cage did not function as intended and did not comply with PUWER Regulations 1998 & BS EN 16228-1: 2014.

All lifting equipment and associated documentation is to be inspected and confirmed safe for use. All lifting accessories are to have fully visible serial numbers and SWL shown on each item. All wire ropes and hydraulic hoses are to be inspected with any items showing signs of wear or damage to be removed immediately with records of the items kept on site.

All rotary rigs with safety mechanism on the cage must conform with PUWER Regulations 1998 & BS EN 16228-1: 2014 and provide full protection for the operators when the machine is in use.
