Safety Alert

Taper Strike Resulting in RIDDOR injury to Traffic Management Operative

SHE H139 A 19
Issued by: Kier Highway SHE
Department
Date: 10/09/2019

Taper Strike Resulting in RIDDOR injury to TM Operative

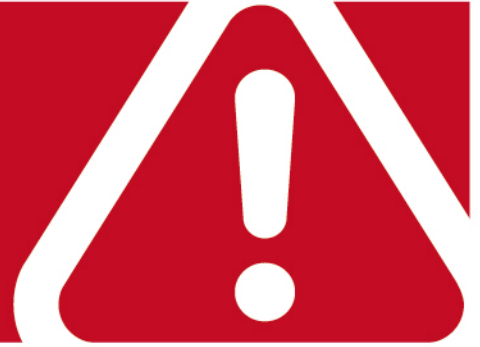
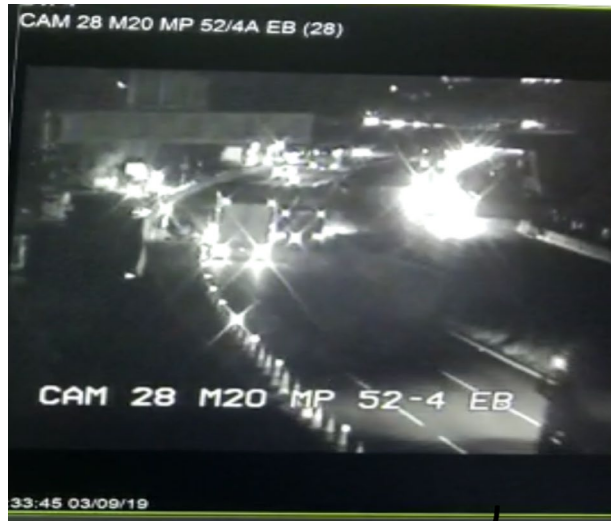
Following the installation of approximately 120m of the taper, the team were working on extending the taper into LBS 2 when a HGV approached. The HGV was blocked from moving into LBS 3 due to another HGV being in that lane. On seeing the HGV approaching, the IP realised that it was going to strike the taper and so retreated towards the Varioguard and a place of relative safety.

The HGV struck the final few cones in the taper causing them to be projected into the safety zone. One of the cone bases struck the IP injuring his lower right leg / ankle. The IP was taken to Maidstone A&E for treatment where a fracture to the right ankle was diagnosed.
