Safety Alert

M6 J33-34 Accident

20 August 2020

Jointline

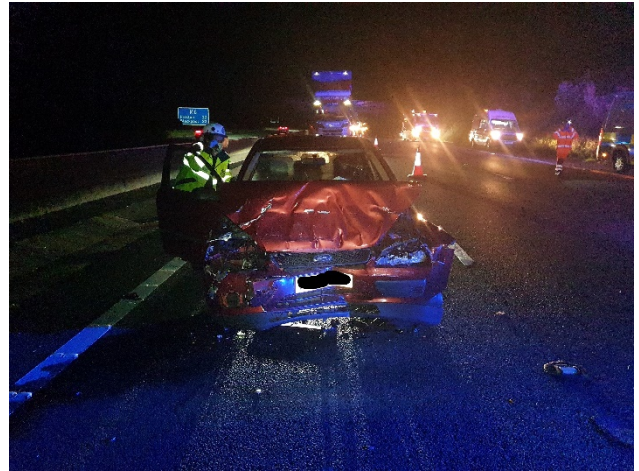
On the 11th of August whilst on stud removal and backfill operations operatives reversed a Jointline vehicle into the live traffic lane outside the TM boundaries causing a serious RTC.

This accident has left a member of the public with significant injuries and has the potential to be life changing.

The method used by the operatives to move the vehicle did not follow Jointlines procedures or site induction rules and allowed the vehicle to enter a live traffic lane.

Whilst it is stated that all vehicles are to remain in the confines of Traffic Management unless using the correct entry and exit points it was not stated that if vehicles had to manoeuvre whilst inside the works that reversing towards a live lane was prohibited.

As a result of reviewing existing controls Jointline have mandated that if you do not have to turn a vehicle around, you **DON'T**.

- Working area design and planning - Can the working area and vehicle/plant selection remove the necessity for the reversing manoeuvre?
- Use the Traffic Management correct exit/entry points - Manoeuvre plant into the correct position by using the Traffic Management exit/entry points.
- After considering the 2 points above, if there is absolutely no alternative **STOP** and consult your Supervisor. Additional checks may be required to facilitate the manoeuvre safely.
