Safety Alert

Overtaken Dumper

Eurovia Contracting North – Dumper Overturned

DATE	23 April 2021
TIME	11:30hrs
LOCATION	Holdingham Roundabout, Sleaford
DIVISION	Contracting North

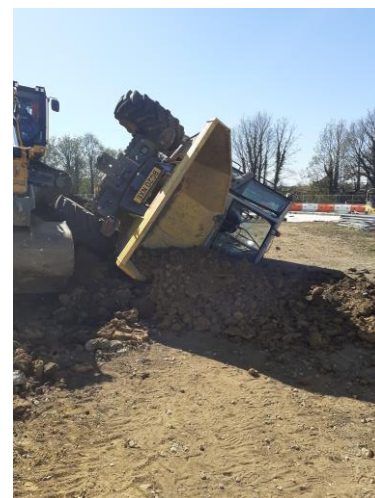
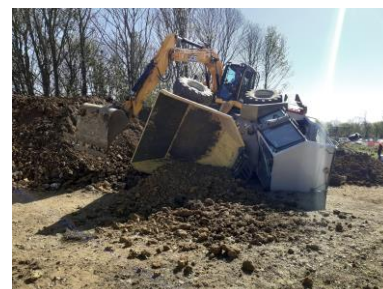
A Supply Chain Partner was carrying out drainage installation works along the A17 East, West Bound approach verge. As part of these works, spoil was being excavated and loaded into a Wacker Neuson DV60 Dual View 6 tonne dumper. The spoil was then transported from the exaction area to a stockpile on site.

The driver had decided to reverse up the stockpile, facing backwards in the incorrect manner. The driver misjudged their position, driving the dumper off the side embankment of the stockpile resulting in the dumper rolling onto its side. The driver exited the cab of the dumper shaken up, but with no apparent serious injuries.

Emergency services were called to the site. The dumper was pushed back to the upright position to prevent any diesel spill from occurring.

D&A testing was called, and all 3 members of the team were tested. The driver was found to have alcohol in their system above the legal limit and was removed from site and taken home by his work colleague.

- Dumper driver induction, competency and previous experience drivers checks to be carried out for all dumper drivers.
- Check and review method statements on plant movements, haul routes to and from stockpiles.
- TBT to be carried out on operating dumper procedures, highlighting seatbelts to be worn when operating dumper/seat belt indicator beacons to be fitted.
