# Safety Alert

## Vehicle Immobilisation

1 June 2021

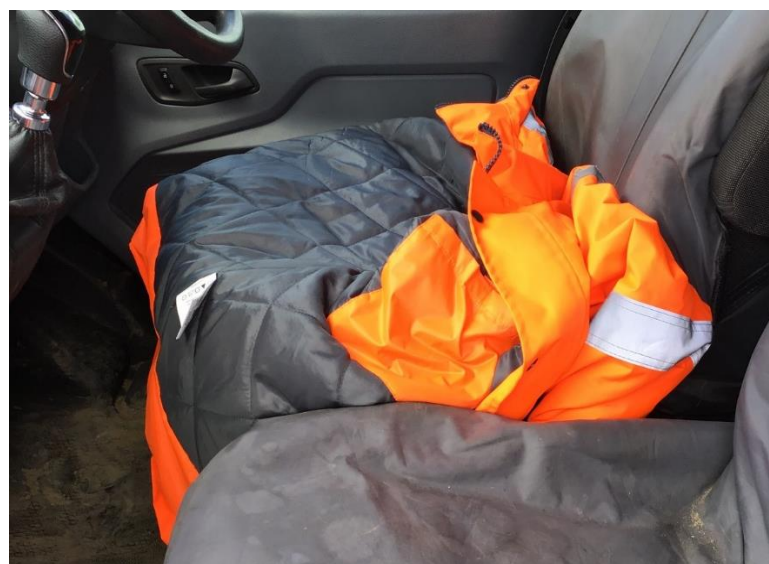
At the end of the shift, the driver moved their vehicle (50m) closer to the hotel reception to sign out. As it had been a wet day, the driver had placed their coat over the driver seat to keep themselves and the seat dry (as shown in the picture).

Whilst in the reception area, signing out, a member of the hotel staff entered and informed the driver that their vehicle had rolled backwards approx. 4 metres into a bush, at the front of the hotel.

- It would appear that the vehicle handbrake had not been engaged, or fully engaged. The driver believes that the coat may have prevented them from effectively engaging the handbrake.
- The vehicle was subsequently checked and the handbrake was found to be working correctly.

- Never cover any safety or control devices of a vehicle.
- Ensure the parking brake is fully engaged prior to exiting your vehicle.
