Form Ref: HSI-10	Independent Health & Safety Inspection – Blue Star Item	Version: 2.0 Jun 2015
---------------------	--	--------------------------

Awarded for Exceptional Performance or New Initiative not widely used on other sites
---	---

Project	Principal Contractor (PC)	Date of Inspection
Kislingbury Farm Underpass	Balvac Ltd	05/10/16
Site Contact	Email Address	Telephone Number
Chris Gyte	Chris.gyte@balvac.co.uk	07730 822000

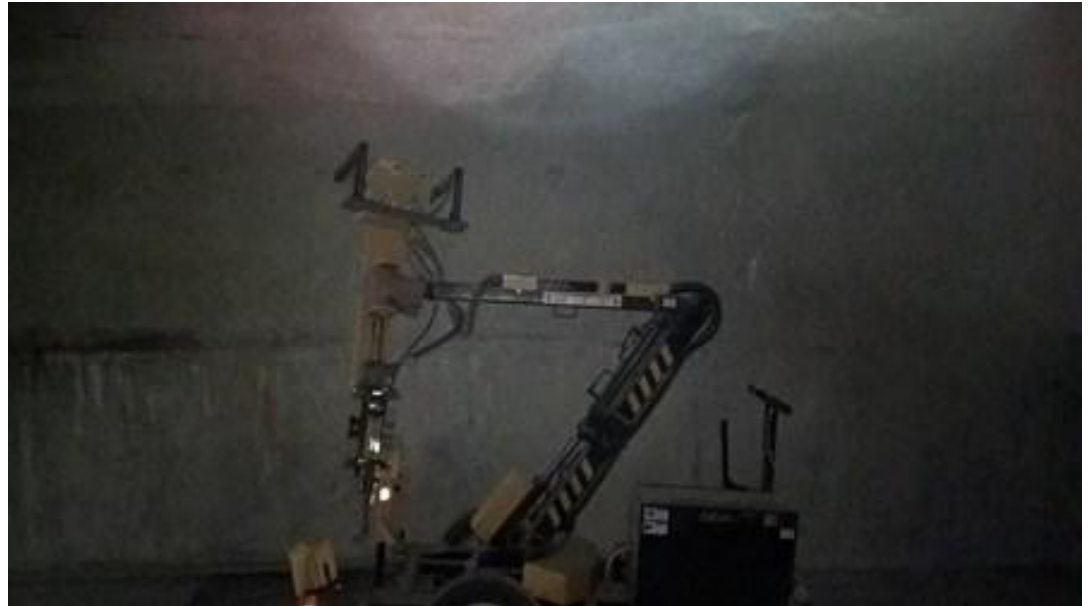
Description of Blue Star Item	<p>PAM Breaker – Fully automated Air / Hydraulic powered mechanical breaker to remove defective concrete from the structure.</p> <p>Reactec HAVwear system to accurately measure each operatives exposure to HAVs when operating vibrating tools. The system recognises each operatives limit value, shows the accumulated points and has a green, amber, red zone to warn the operative of their daily exposure</p>
Benefits of Blue Star Item	<p>PAM Breaker – No vibration experienced by the user. Productivity increased when breaking out larger repair areas</p> <p>Reactec HAVwear – Monitors each operative exposure to vibration. Is worn similar to a watch on the wrist thus less restriction to user as compared to earlier HAVtag monitoring equipment</p>
Details and Cost of any Specific Product	<p>PAM Breaker – In excess of £32K</p> <p>Reactec HAVwear – £3K / Base unit, monitors approx. £ 150/unit. Plus subscription fee to download the data</p>

PAM Breaker

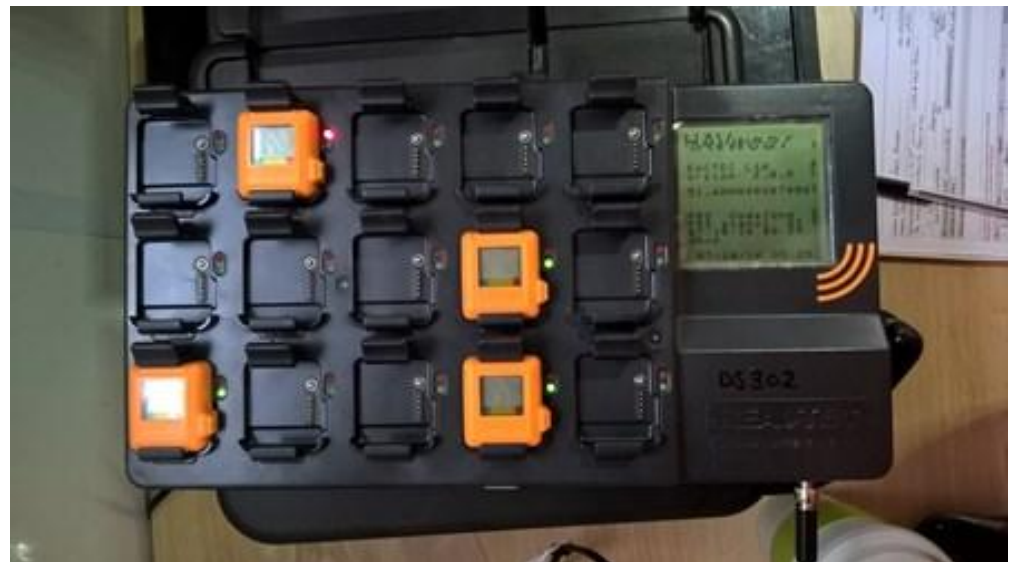
Reactec HAVwear
