INFORMATION

20 March 2023

Background information

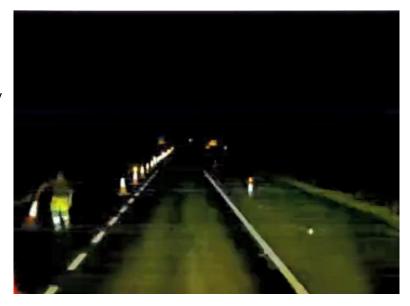
- On 28 February 2023, a low loader driver arrived at the scheme meeting point for a surfacing scheme on the A21 at Flimwell junction. The meeting point was a layby on the A21 carriageway.
- At the time of this driver's arrival, the layby was closed off with traffic management cones, and no operatives were present on site. The driver then:
 - Stopped the vehicle in the live carriageway, blocking the A21 southbound
 - Exited the vehicle into the live carriageway
 - Failed to wear the correct 5-point PPE
 - Moved the traffic management cones to allow access for the vehicle to the layby
 - Put himself and customers at unnecessary risk

- The written and agreed site arrival time was 20:30, however the driver arrived at 19:10.
- The driver's rules instructed that contact with the site supervisor was to be made 10 – 15 minutes prior to arrival to the meet point. The driver failed to contact the site supervisor.
- Without any approval, the driver stopped the vehicle in a live carriageway, blocking the road, and then exited the vehicle.
- The vehicle was stopped on a live carriageway without any impact protection.
- The driver moved traffic management without any training or authority to do so.

- The Principal Contractor (PC) re-inducted their subcontractor hauliers on high speed traffic management entry/egress procedures.
- Refresher training on high speed traffic management entry will now be delivered every 6 months to all drivers working on behalf of the PC.
- Departure and arrival times for vehicles to be reviewed prior to scheme commencing.
- All meeting points will be reviewed during planning to ensure they are suitable and sufficient for the scheme requirements.
