Safety Alert

Parking of Traffic Management Vehicles in Longitudinal Safety Zones Lane Closures

4 April 2023

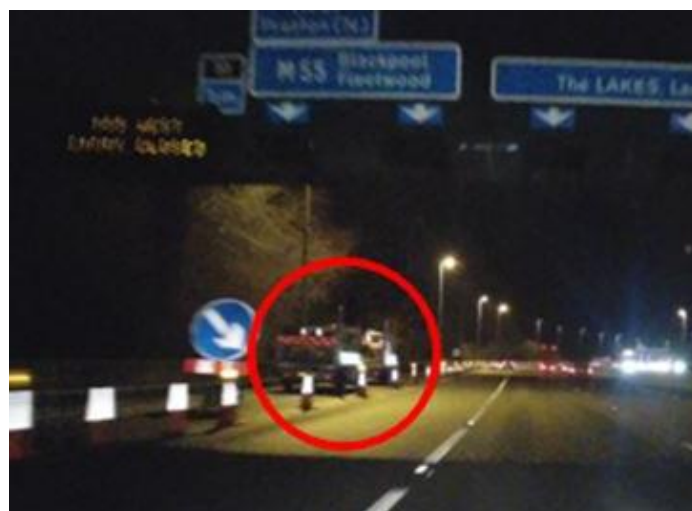
Incorrectly parked vehicles, especially with headlights facing oncoming traffic, may cause uncertainty and confusion.

Example of vehicle parked in longitudinal zone

As stated in the Traffic Signs Manual Chapter 8 and as covered in national training courses, longitudinal safety zones must be kept clear of all parked plant and vehicles.

Parking vehicles in safety zones puts customers and workers at increased risk and all sites and providers are required to immediately implement appropriate measures to ensure that this activity ceases.
