Safety Alert

Car struck by falling concrete

13 April 2023

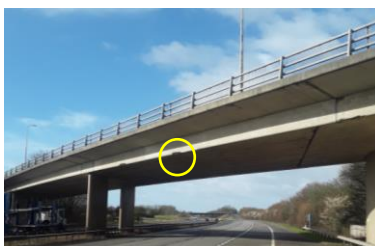
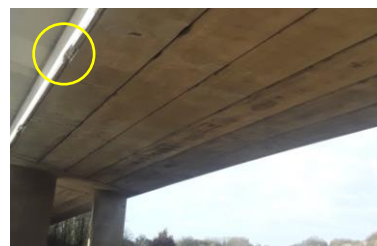
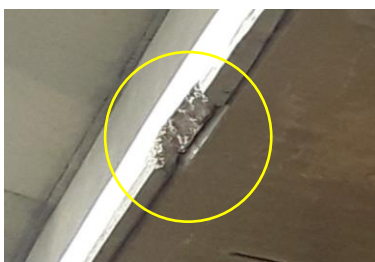
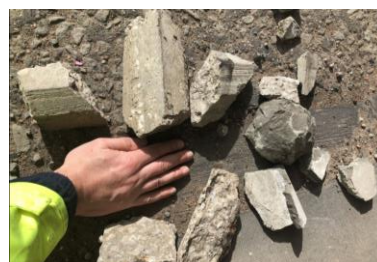
A small section of concrete from a motorway overbridge became loose and fell striking a car.

A subsequent investigation confirmed that the detached concrete was part of a historic repair to the lower edge of the in-situ concrete fascia, to the side of the bridge deck.

The most recent Inspection in 2022, did not identify any defects at the location, and photographs from around that time appear to show no obvious cause for concern with no signs of debonding, delamination or cracking.

Initial indications suggest the repair was not adequately bonded around the existing reinforcement.

CS 462 requires structural repairs to be secured in place by encompassing reinforcement, and by adhesion of the repair material to a roughened substrate.

If this is impractical, small diameter dowels may be bonded into the existing concrete, subject to agreement with the Technical Approval Authority.

Non-structural repairs, which are those secured in place only by adhesion to the substrate, are not permitted above highways or other areas used by the public or workforce.

- Inspectors should check for delaminated areas of concrete during Principal Inspections by hammer-tapping, and any loose concrete shall be removed.
- Any loose concrete identified during General Inspections that poses a risk to the public should be removed as soon as reasonably practicable, with measures taken to mitigate the risk in the interim if appropriate.
- Designers should consider whether concrete repairs to non-structural elements above live traffic are necessary.
- Structural repairs must be secured in place mechanically by encompassing the reinforcement, and by adhesion of the repair material onto a roughened substrate.
- Where repairs are considered impractical the Technical Approval Authority should be consulted.
