Safety Alert

Wet Rot - Critical structural defect

27 April 2026

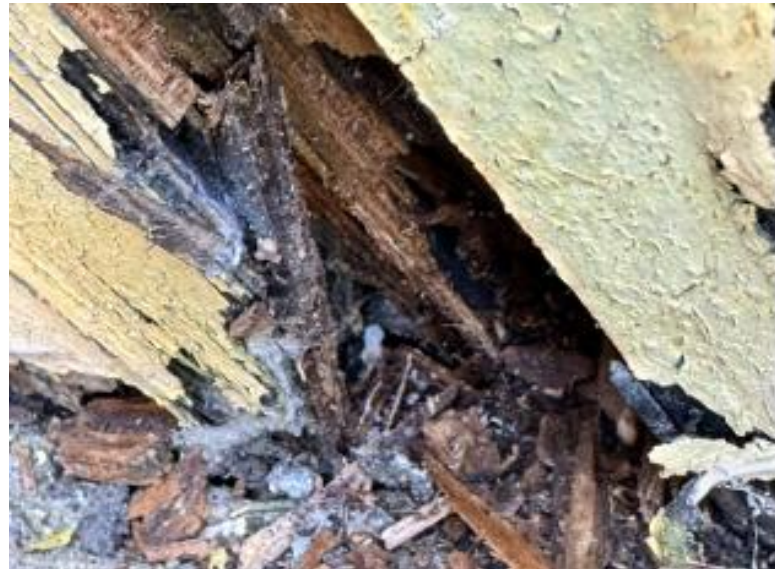
The inspection has identified Critical Structural defects. The primary load bearing LVL (Laminated Veneer Lumber) portal frame columns, specifically those bearing directly onto concrete plinths without proper isolation, have suffered catastrophic structural failure due to advanced wet rot.

The inspection revealed that the effective structural cross-section at the base of several key columns has been reduced by an estimated 70-80%. The hygroscopic nature of the stored road salt has exacerbated this decay.

The loss of section at the column bases significantly compromises the building's ability to resist wind and snow loading. There is a foreseeable risk of partial or progressive collapse under adverse weather conditions or accidental vehicle impact.

The structure is currently in a critical condition with a three-meter cordon in place and has been removed from all operation use.

Annual Inspection Regime for all LVL (Laminated Veneer Lumber) supported buildings with prioritisation of Salt barns and salt storage buildings.

Cleaning and maintenance schedule for gutter clearing and maintenance to be increased for LVL supported buildings.

Note: Visual inspections are not adequate in identifying Wet rot with LVL (Laminated Veneer Lumber)
