Safety Alert Concrete Spacer Block Asbestos

09 January 2023

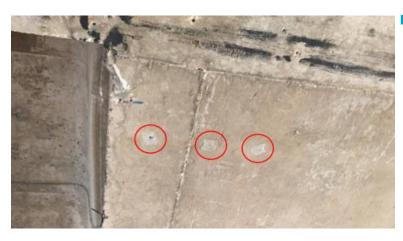
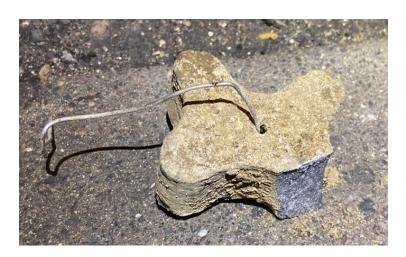
A recent investigation of a concrete bridge deck identified a 'concrete' reinforcement spacer block with traces of white fibres. The sample was tested and confirmed the presence of a small amount of white asbestos fibres in a cement matrix.

All concrete removal activities involving structures built prior to 1999, must assume the potential presence of asbestos fibres in asbestos cement spacer blocks. Such works are classified by the Health and Safety Executive (HSE) as non-licenced works.

- HSE guidance is that the health risks from asbestos cement spacer blocks are extremely low, and activities such as inspection, maintenance and concrete repairs are not defined as work with asbestos. Normal good practices such as dust suppression and prewetting of concrete surfaces during mechanical concrete removal are sufficient to minimise risks.
- Concrete demolition waste can be crushed and recycled but should be kept damp. If asbestos cement spacers are found during works, they should be identified with paint. Workers undertaking work which would involve disturbing reinforced concrete should follow appropriate guidance regarding PPE.
