# Safety Alert

## Robel Lithium-ion Battery and Robel Tamper

## SHE Alert 01 in 2022

### Stop use – Robel lithium-ion battery and Robel tamper

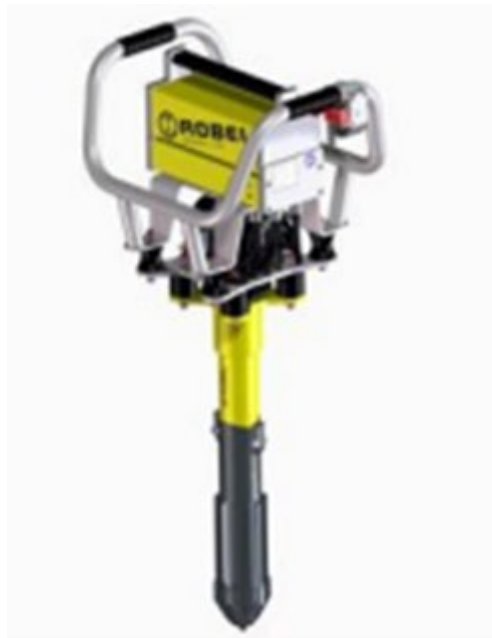
There was an incident on Network Rail whereby a Robel lithium-ion battery was removed from a charger and placed on a 62.20 vertical tamper. When the test button was pushed a loud bang and a puff of smoke was emitted from the Robel vertical tamper unit.

The equipment was placed in quarantine. The next morning the battery was unclipped from the vertical tamper and placed on the floor for inspection. After two minutes a hissing noise was heard coming from the battery followed by smoke. The Fire Brigade were called to the incident and the battery was made safe.

Robel 60.20 battery tamper

You must stop using the following immediately and make sure the batteries are removed from the plant and both are stored safely until further notice:

Robel model 60.20 tamper  
Robel model 10.20 rail drill  
Robel model 30.20 impact wrench  
Robel model 12.20 rail band saw
