Services encased or surrounded by concrete

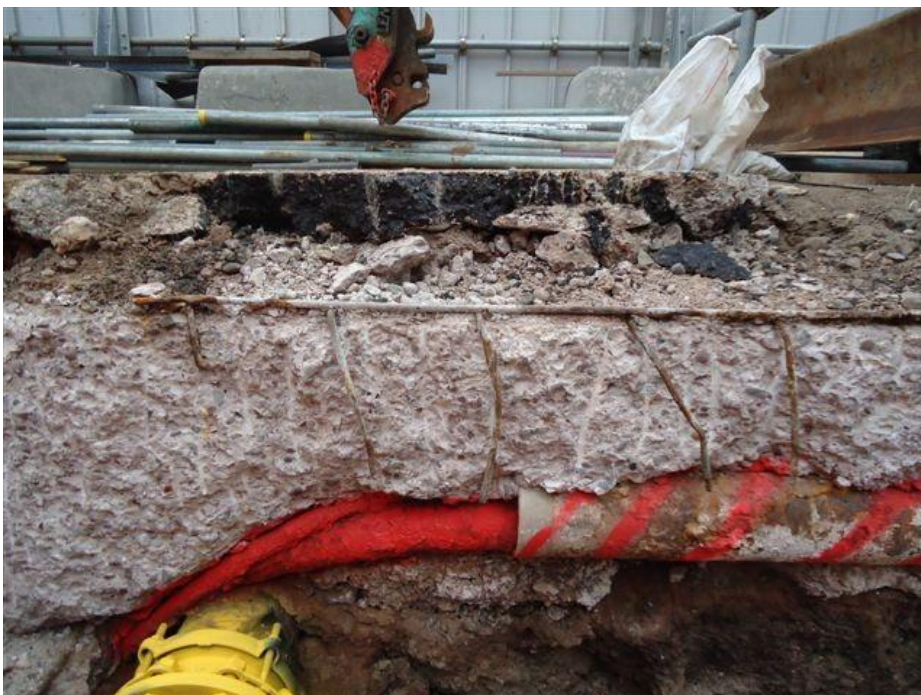
The decision map / flow chart (Item 7 on the micro-site) describes a simple way to manage the discovery of services encased in or surrounded by concrete.

This is primarily aimed at site supervisors, team leaders and site managers, but is also applicable to designers / planners.

The principle that when any service is discovered to be encased or surrounded by concrete **work must stop**, to establish the reason for the concrete being present. Ideally a **diversion** or (if that is not reasonably practicable) **isolation** of the services should be adopted. This “decision map” / “Flow-chart” should be used, which is equally applicable at design (survey) stage as it is in construction or maintenance stages.
