BRIDGE STRIKE – MATERIAL DELIVERIES

WLD.012

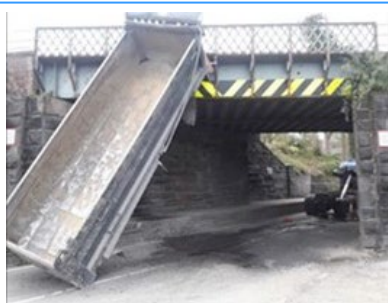
Photo of wagon colliding with bridge deck and become dislodged – view from road.

- Use digital technologies to inform driver that body is raised when moving.
- Use site worker to confirm the body is lowered prior to leaving site.
- Install mirrors at site exit that enable driver to self-check body is down.
- Use augmented reality to inform driver of approaching overhead structures.
- Provide warning signage identifying the vehicle height and width.

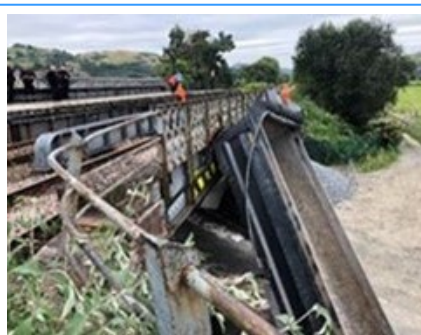
Photo of wagon having collided with bridge deck.
