STRUCK BY MOVING VEHICLE - MAINTENANCE OF LIGHTING COLUMN

(Apr 25)

WLD.044

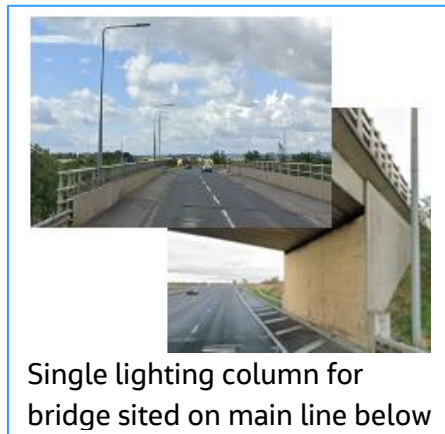
- When designing and installing two lighting columns for the interchange overbridge, vehicle speeds and impact, incursions, work at increased height and exposure time for installing additional traffic management on both main carriageway and on the bridge do not appear to have been considered.
- Lighting maintenance requires traffic management enclosures for access and public protection and in addition, lighting column push/pull tests require lane 1 closure on each carriageway for each column.

Single lighting column for bridge sited on main line below

- Consider removal of these lighting columns over the bridge [TA 501](#)
- Carry out risk assessment of maintenance options, see [GG104](#) risk Assessment if lighting is required & [GD304](#) A5.
- Provide off road access areas for MEWP, consider passive columns
- Consider departures from standards and relaxation of lighting levels for the need to illuminate the bridge or to adapt an adjacent column with different spacing.
